RENAISSANCE ZONE AUTHORITY

MEETING AGENDA

J&R Vacuum & Sewing — Condition Assessment for Exterior Envelope Assemblies

Conducted by Joseph P Larrivee (JPL) Architects

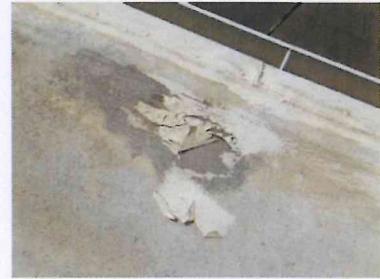
Figure 3: This is an example of severely ravelled and delaminated roof patches.

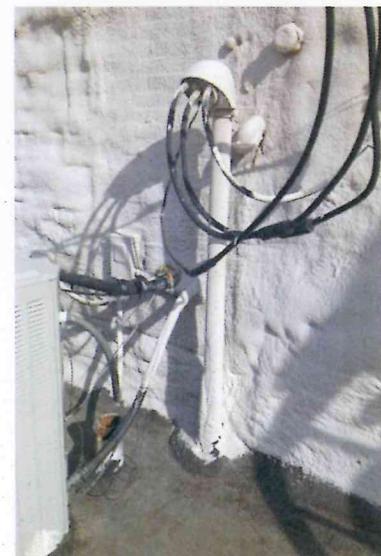
Figure 4: This is the location of the electrical service entrance and rooftop condensers on the single story shed roof at the south elevation of the building. Jim reports that this has been a problematic roof area.

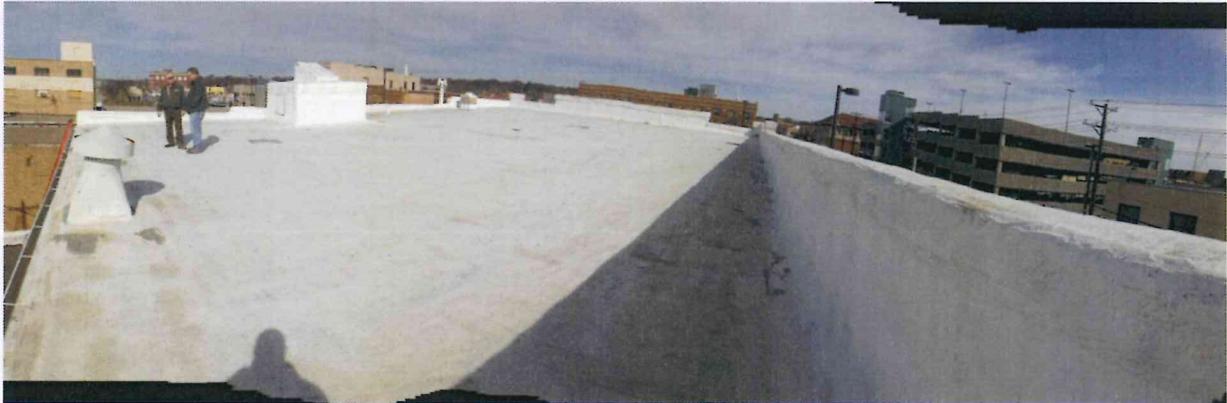
Figure 6: An overview of the upper roof taken from the southeast corner. The white surface is the protective coating system. The smaller grey areas indicate locations where the coating and membrane have been patched.

The upper roof is in poor condition. At fifteen years of age, we believe it has reached the end of its expected service life.

The top layer of the upper roof — the protective coating and membrane system — is worn and ravelled⁸. As the protective coating has broken down over time, the membrane has been exposed to the sun, weathered and become brittle. The brittle membrane has led to cracks and openings which we observed while on the roof.

Jim reports that the roof has required frequent, ongoing maintenance for these and related issues. Maintenance efforts are clearly evident in the large number of grey patches that cover the roof surface. Despite all of the patching that has happened in the past, many cracks and openings still remain.

It is clear that the rate of the roof failures has now outpaced the reasonable rate that the roof can be repaired.

The roof should be scheduled for replacement.

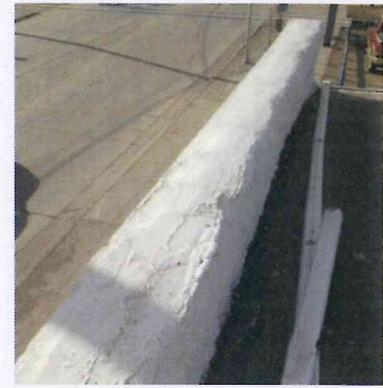
Figure 5: The parapet at the lower roof. Removed downspouts are visible in this photo.

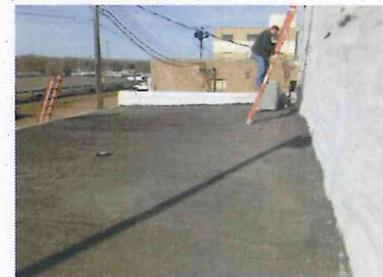
Figure 7: An overview of the lower roof. The lower roof is comprised of a BUR system without the foam and protective membrane and coating system.

Ironically, the lower roof — which may be older than the upper roof — appears to be in better condition.

This may be attributed to the 'robustness' of the time-proven BUR system. While the system was probably more labor intensive and expensive than the spray-applied system on the upper roof. It has stood the test of time and ongoing repairs appear to have been more effective.

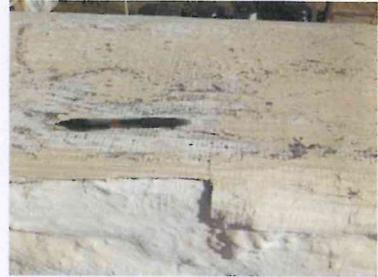
Figure 8: The severely ravelled membrane on the parapet of the upper roof. The individual fibers of the protective membrane are visible. A pen is present for scale.

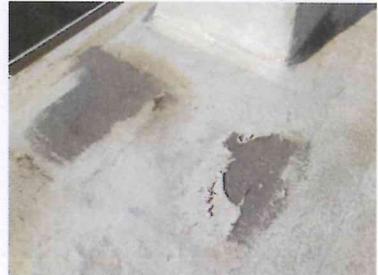
Figure 9: Grey Roof patches: patches in the past have used a different coating system – or at least it is a different color: grey vs. white. Adhesion of the patch appears poor. Some fraying of the existing membrane is also visible in this photo.

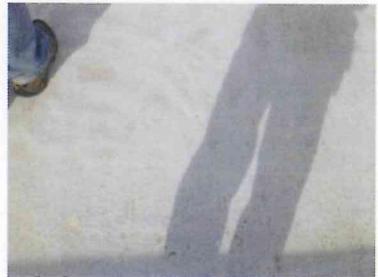
Figure 10: 'Bubbles' from the uneven installation of the insulation below are telegraphed through to the roof surface.

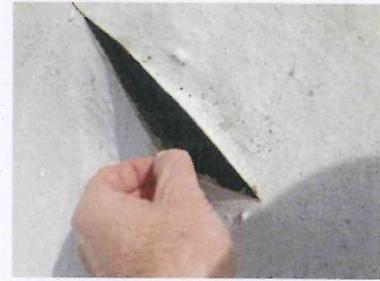
Jim Barnhardt reports that leaks have been a problem when large snow loads are present on the roof surface. When snow is present, small drips will appear in the ceiling of the second floor warehouse area. These leaks seem to stop once snow has melted and do not reappear during the rains of summer. These leaks are due to the membrane cracks visible in the photos to the right — and probably many other cracks and breaks that are not visible.

Figure 11: This is a large break in the existing roof protection membrane. This break allows water penetration to the insulation and old BUR surface below. Due to the presence of the old roof below, water that penetrates the top roof surface is most likely trapped between the two roof systems. Some of it eventually makes its way through to the second floor ceiling in the form of small leaks.

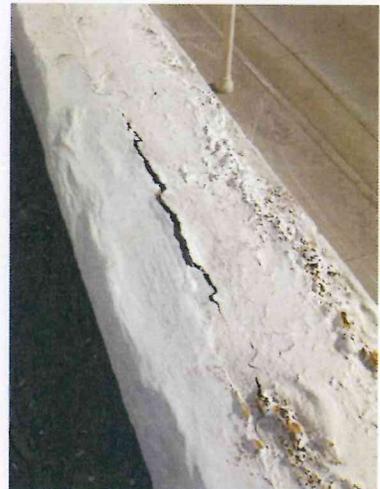
Figure 12: This is a large break in the existing roof protection membrane at the parapet along the east edge of the upper roof. These large cracks were fairly typical at the top of the parapet wall.

We believe that moisture infiltration into the soft surface of the existing common brick wall finishes is leading to the failure of these cladding systems. We believe that the source of this water is failed roof and parapet flashings and the open surfaces of the wall cladding materials themselves. Furthermore, these cladding systems (the paint, stucco and foam) serve to trap any water that infiltrates the wall and hold it in place. This is a critical problem during the winter months when the trapped water infiltrates the surface of the brick and initiates the damaging freeze-thaw cycle. Please note that the parapet openings shown in Figure 12 and Figure 16 are an obvious source of water infiltration.

A new metal cap flashing system will be installed to protect the tops of the existing walls and prevent water infiltration.

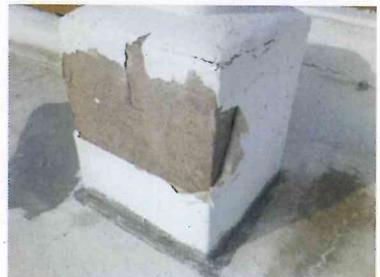
Figure 13: The roof protection membrane has totally peeled away from the face of the masonry chimney.

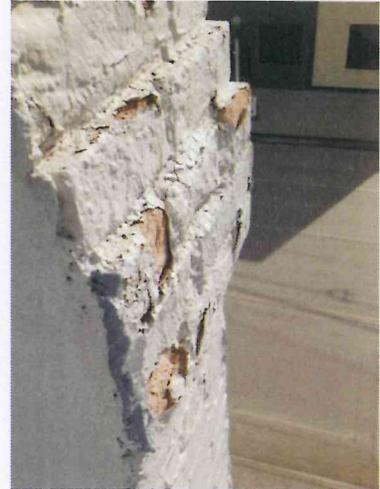
Figure 14: Peeling paint and crumbling brick at the parapet in the southeast corner of the upper roof.

Once water is trapped in the soft surface of the common brick, the brick is susceptible to accelerated deterioration via freeze-thaw action. In the case of the paint, the trapped water has caused the paint to lose adhesion to the surface of the brick or caused the surface of the brick to split and fall away. Please see Figure 14 above.

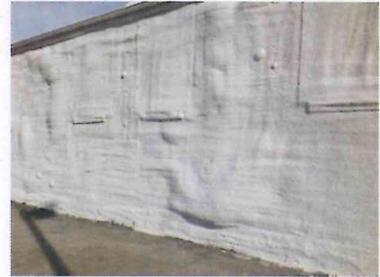
On the second floor of the building at the south elevation, the existing brick surface has been coated with the same 'SPF' system used on the roof. Like the paint and stucco, this system has also failed and is sagging away from the wall surface. Please see Figure 15. As in the case of the wall paint, we believe that the surface of the brick has failed and is now adhered to and falling away with the foam insulation.

Figure 15: This is the exterior wall at the second floor south elevation. We believe that the same system used to insulate and overcoat the roof was used here. Note that large areas of the insulation have delaminated from the surface of the brick and are sagging away from the building. Jim Barnhardt reports that brick dust falls from this area onto the shop floor from an open joint in the ceiling.

In the case of the plaster, the trapped water has led to failed metal lath¹⁰ and fasteners. The failure of the SPF system or foam on the walls is similar to the failure of the paint. Freeze-thaw action has caused the surface of the brick to break away from the rest of the wall. The foam and the rest of the wall coating falls away with it. Please see Figures 15 and 16 above.

This deterioration is also evident at the interior of the building. Spalling of the brick was noticeable at the interior surface of the exterior wall near the stairs to the upper level. Also, Jim Barnhardt reports that 'brick dust' is constantly falling from the overhead joint between the double and single story portions of the building. This location correlates with the foam-covered exterior wall noted above. Please see Figure 15 above.

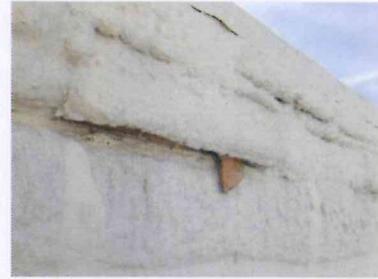
Figure 16: Roof parapet. Note that the foam coating adhesion to the brick has failed and a large piece of brick is falling from the opening.

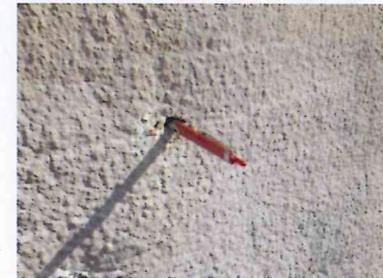
Figure 17: This is a large hole in the foam wall coating system.

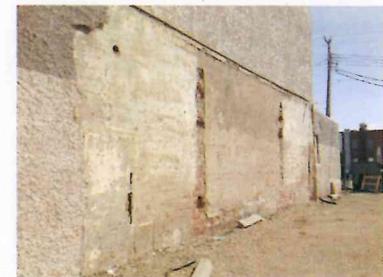
Figure 18: Large areas of the plaster wall cladding at the west elevation are missing.

As reported above, there are large portions of the exterior wall finishes (plaster and foam) that have delaminated from the brick wall substrate. These areas need to be removed and the substrate below evaluated for damage and repaired if necessary. Based on damage that we have seen in exposed areas and based upon the spalling and brick dust that have settled out of ceiling and wall cracks, we can safely assume that the surface of the brick will be delaminated and damaged. We will try to work with this surface damage without significant repair. However, if the brick masonry is substantially damaged, we anticipate some replacement or re-pointing of the masonry may be required in some areas before we can proceed with new wall finishes.

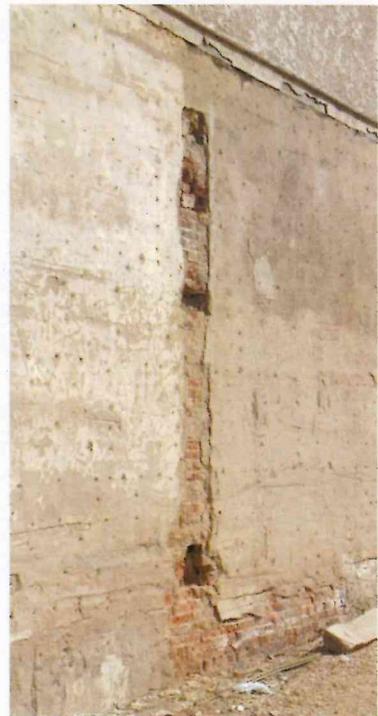
Figure 20: Large areas of the plaster wall cladding at the west elevation are missing.

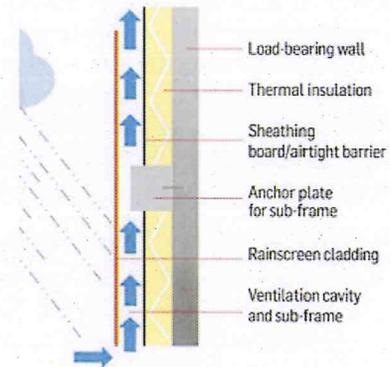
Figure 21: Rainscreen diagram.

At this time we anticipate a metal sub-frame and sheathing system that will allow us to stabilize the wall with additional structure and

create a surface for new weatherization and finishes. At the parapets this system will be located on both sides of the wall forming a 'sandwich.' We will propose the use of through-wall versus surface fasteners to hold this framing system in place. Through-wall fasteners will be bolted in place at the interior of the building wherever possible. This will allow larger fasteners that will not rust away as has occurred in the past. Stainless steel or galvanized fasteners could be employed to reduce the rate of corrosion.

This new system of metal framing, sheathing and weatherization barrier will 'stand-off' from the exterior face of the existing wall allowing air to circulate through the system to ventilate the wall system.

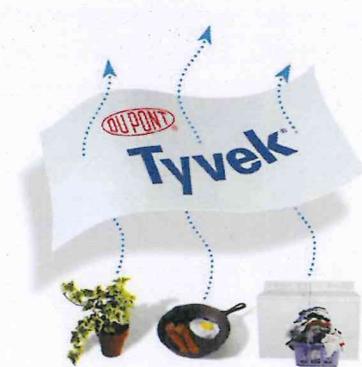
Figure 22: Tyvek diagram.

Water and Moisture Protection — Water infiltration will be prevented via a number of measures: 1) As mentioned above, we will install a new metal cap flashing system to prevent water infiltration at the top of the existing walls. We will also flash the new rubber membrane roof over the tops of the parapet walls to form a second layer of protection; 2) The surface of the new exterior wall sheathing will be covered with a Tyvek¹² weatherization membrane. Tyvek is a breathable construction membrane that allows water vapor to pass through but prevents the infiltration of liquid water. This will allow the wall system to stay relatively dry during most times of the year — keeping out the rain and snow and allowing interior moisture to pass through and ventilate the wall system.

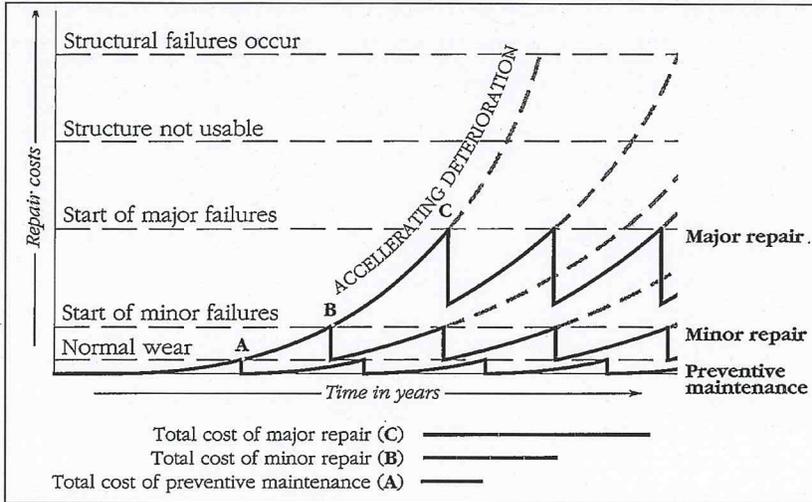
If depreciation can be funded on an annual basis, the dollars expended can be maintained at the level of 'Preventative Maintenance' and 'Minor Repair' in the graph at Figure 24.¹⁴

Please note that unchecked deterioration accelerates over time at a logarithmic rate. Before long, funding deferred maintenance and ignored depreciation becomes untenable. This is illustrated in the 'ACCELERATING DETERIORATION' curve at Figure 24. As these curves approach the vertical plane, repair costs

Figure 24: Preventative Maintenance Diagram. This diagram is from *How Buildings Learn*, p. 112

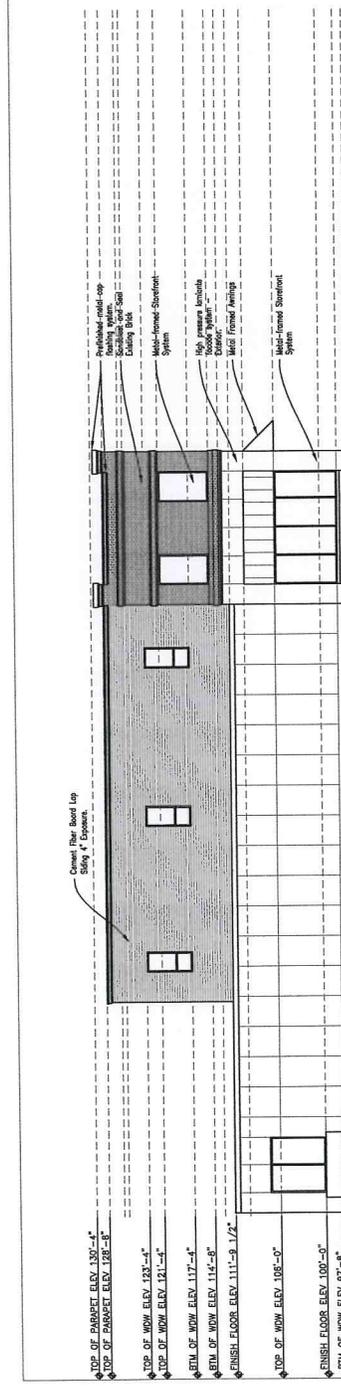
2 EAST ELEVATION
1/4" = 1'-0"

Cement Fiber Board Lap Siding 4" Exposure.

- Prefinished metal cap flashing system.
- Sandblast and Seal Existing Brick
- Metal-framed Storefront System
- High pressure laminate facade system - Exterior.
- Metal Framed Awnings
- Metal-framed Storefront System

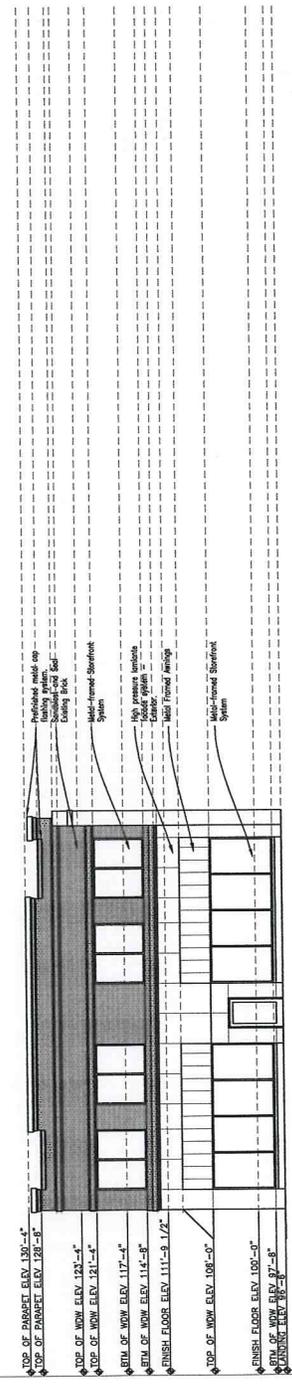
1 NORTH ELEVATION
1/4" = 1'-0"

- Prefinished metal cap flashing system.
- Sandblast and Seal Existing Brick
- Metal-framed Storefront System
- High pressure laminate facade system - Exterior.
- Metal Framed Awnings
- Metal-framed Storefront System
