## BECEP at Richholt School

TALKED WITH: Michelle Hogan, BECEP at Richholt  
RECORDED BY: Donovan Slag  
PROJECT: School Crossing Study  
SUBJECT: School Crossing Issues  
DATE: October 21, 2004

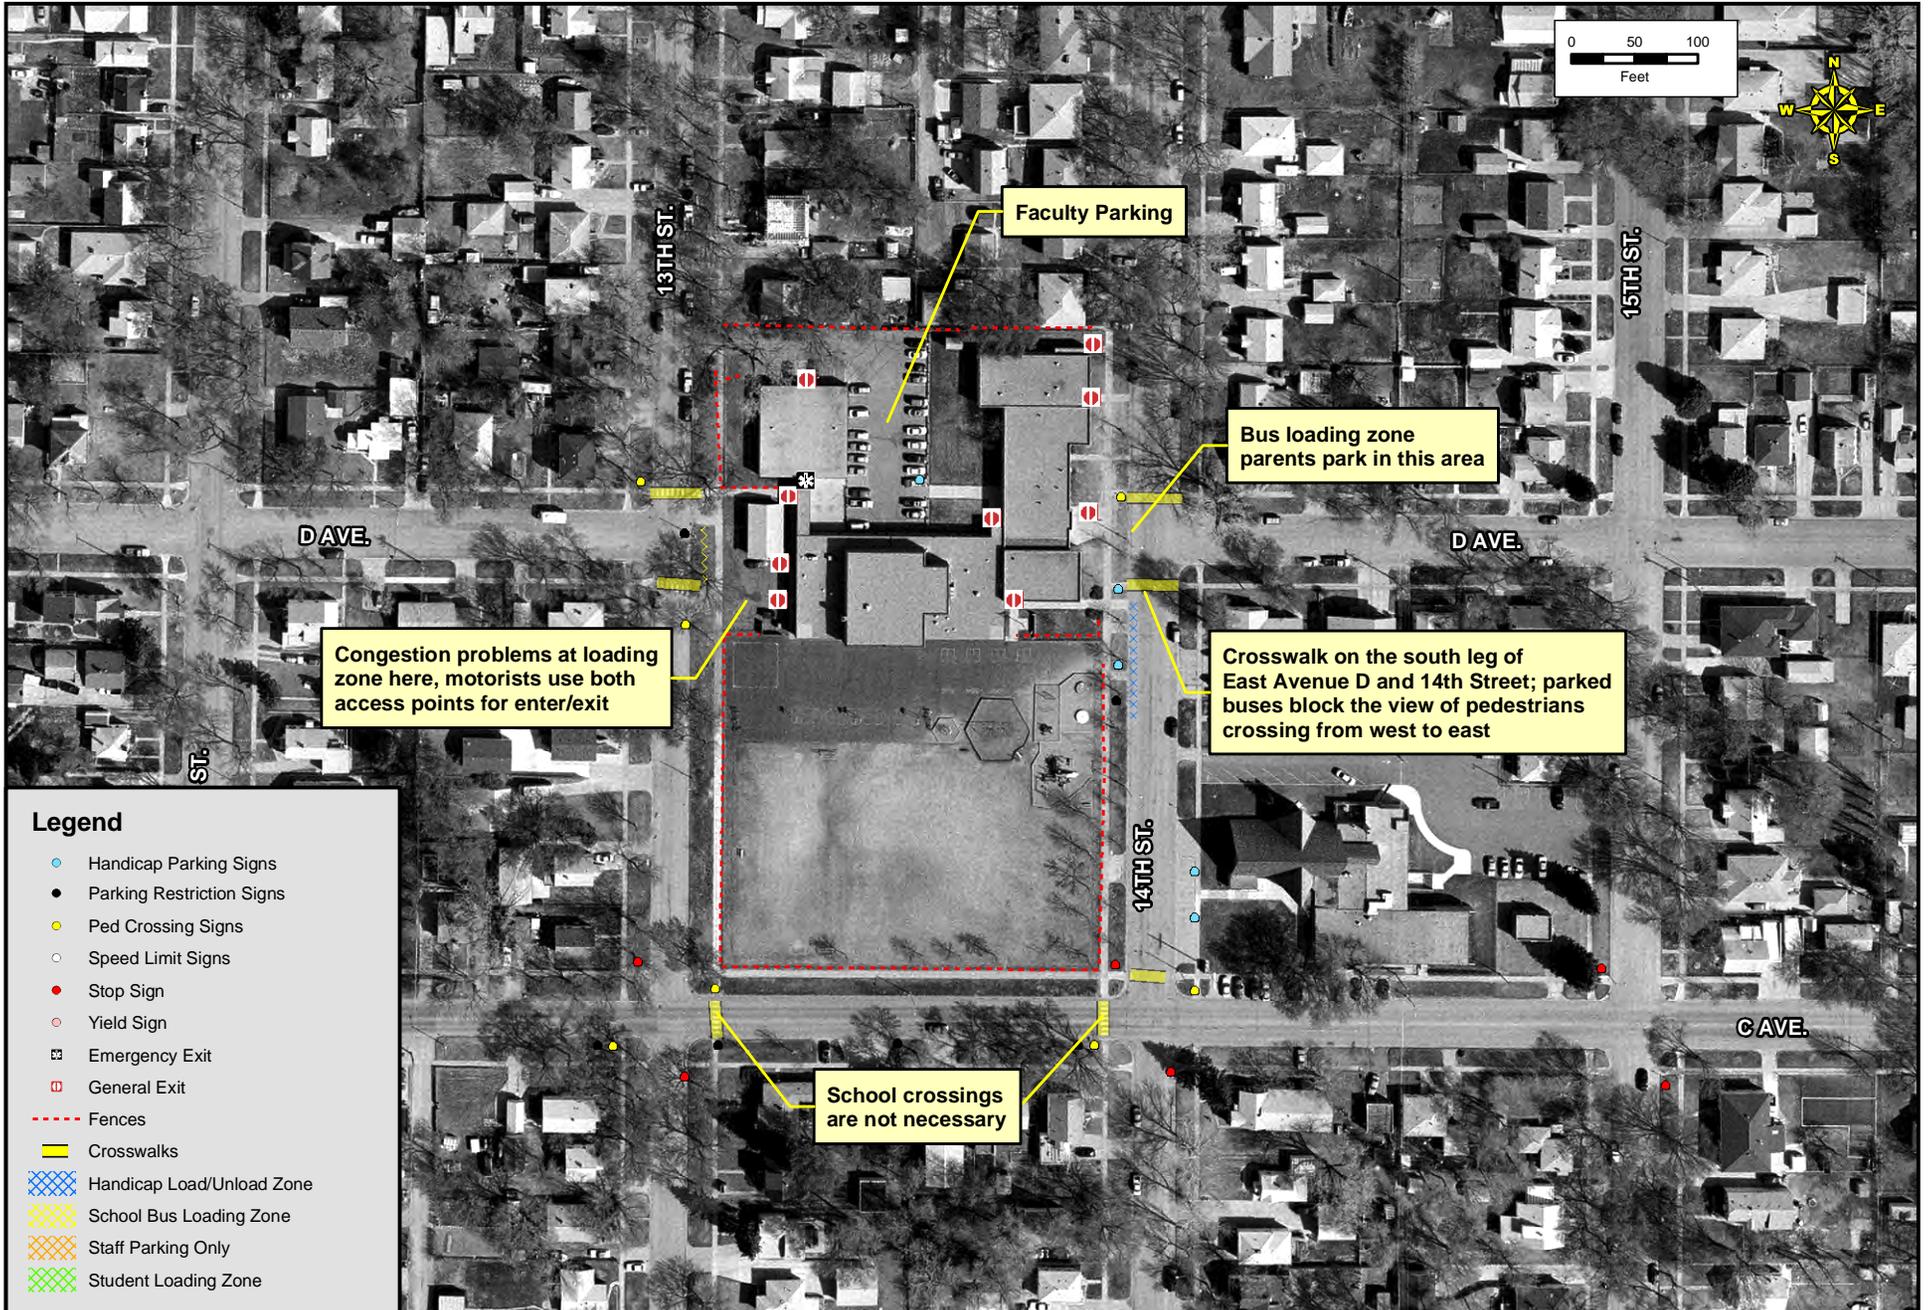
# BECEP AT RICHHOLT SCHOOL ISSUES AND OBSERVATIONS MAP

- Parents park in bus loading zone.
- Congestion problems at loading zone on west entrance.
- Not enough parking or loading area for parents to drop-off/pick up.
- The bus loading zone blocks view of pedestrians on south leg of Avenue D and 14<sup>th</sup> Street.

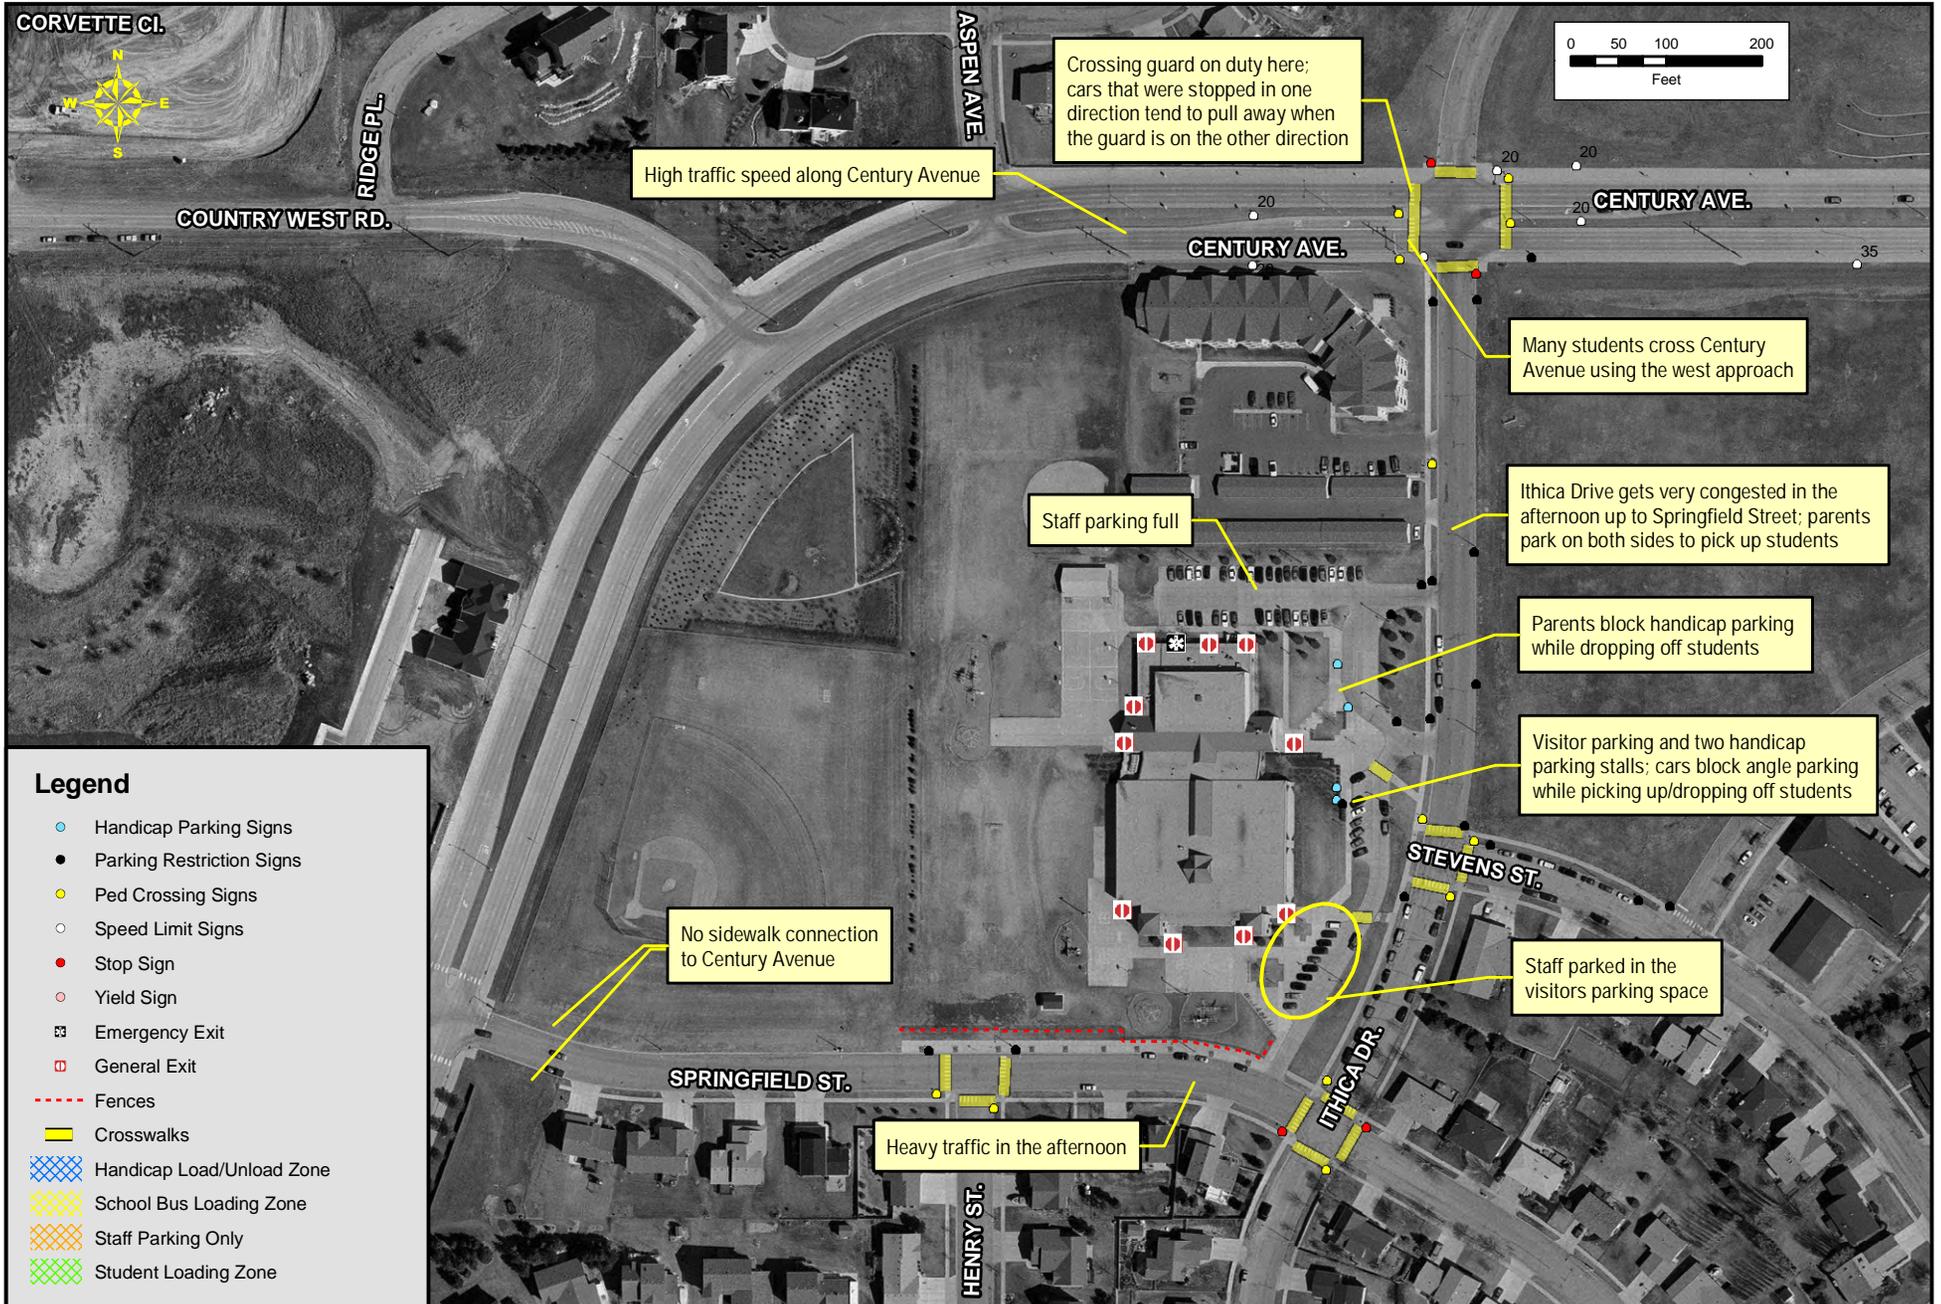
# CENTENNIAL ELEMENTARY SCHOOL ISSUES AND OBSERVATIONS MAP

- Traffic congestion and parking violations around the southeast end of school during drop-off and pick up.
- Diagonal visitor parking area becomes gridlocked. Parked vehicles are unable to back out of parking spot due to stacked vehicles behind them.
- Parking demand exceeds capacity near school entrances.
- Lack of sidewalks on some approaches to school.

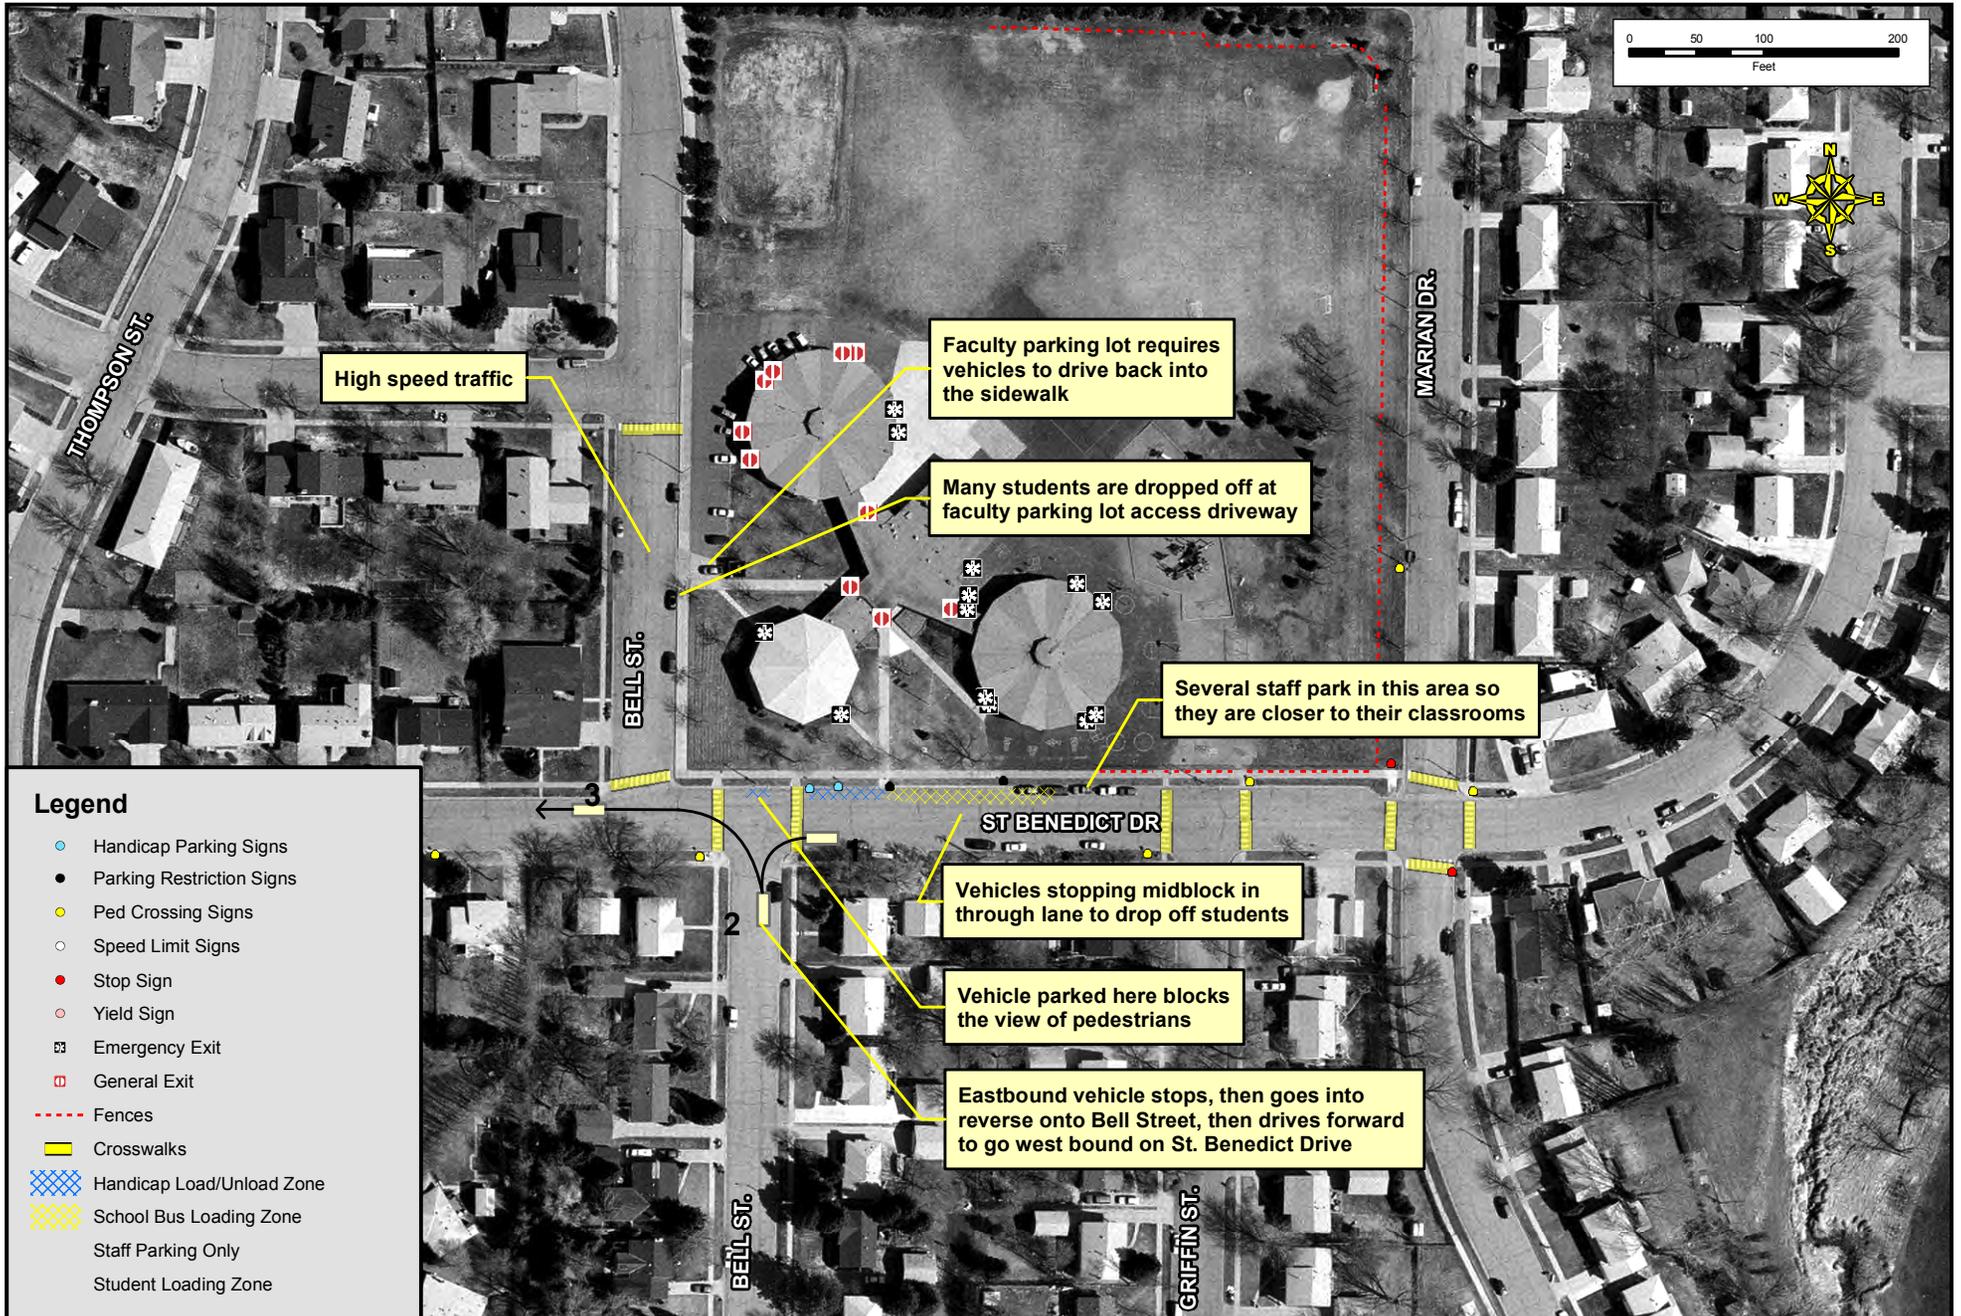
# GRIMSRUD ELEMENTARY SCHOOL ISSUES AND OBSERVATIONS MAP

- Vehicle speeds are too fast along Marian Drive and along Bell Street.
- Many students do not use the crosswalks along Marian Drive, they cross at mid-block locations.

- Lack of continuous sidewalks causes students to walk in the street which creates close calls.
- Some parents traveling southbound along Marian Drive drop their children off at the intersection of St. Benedict Street causing visibility problems for others.

- A crossing guard is needed for this school.
- Some parents double park blocking the traffic flow.
- The parking lot entrance crosses the sidewalk close to a school entrance. On several occasions it has been observed that vehicles back up and over the sidewalk.

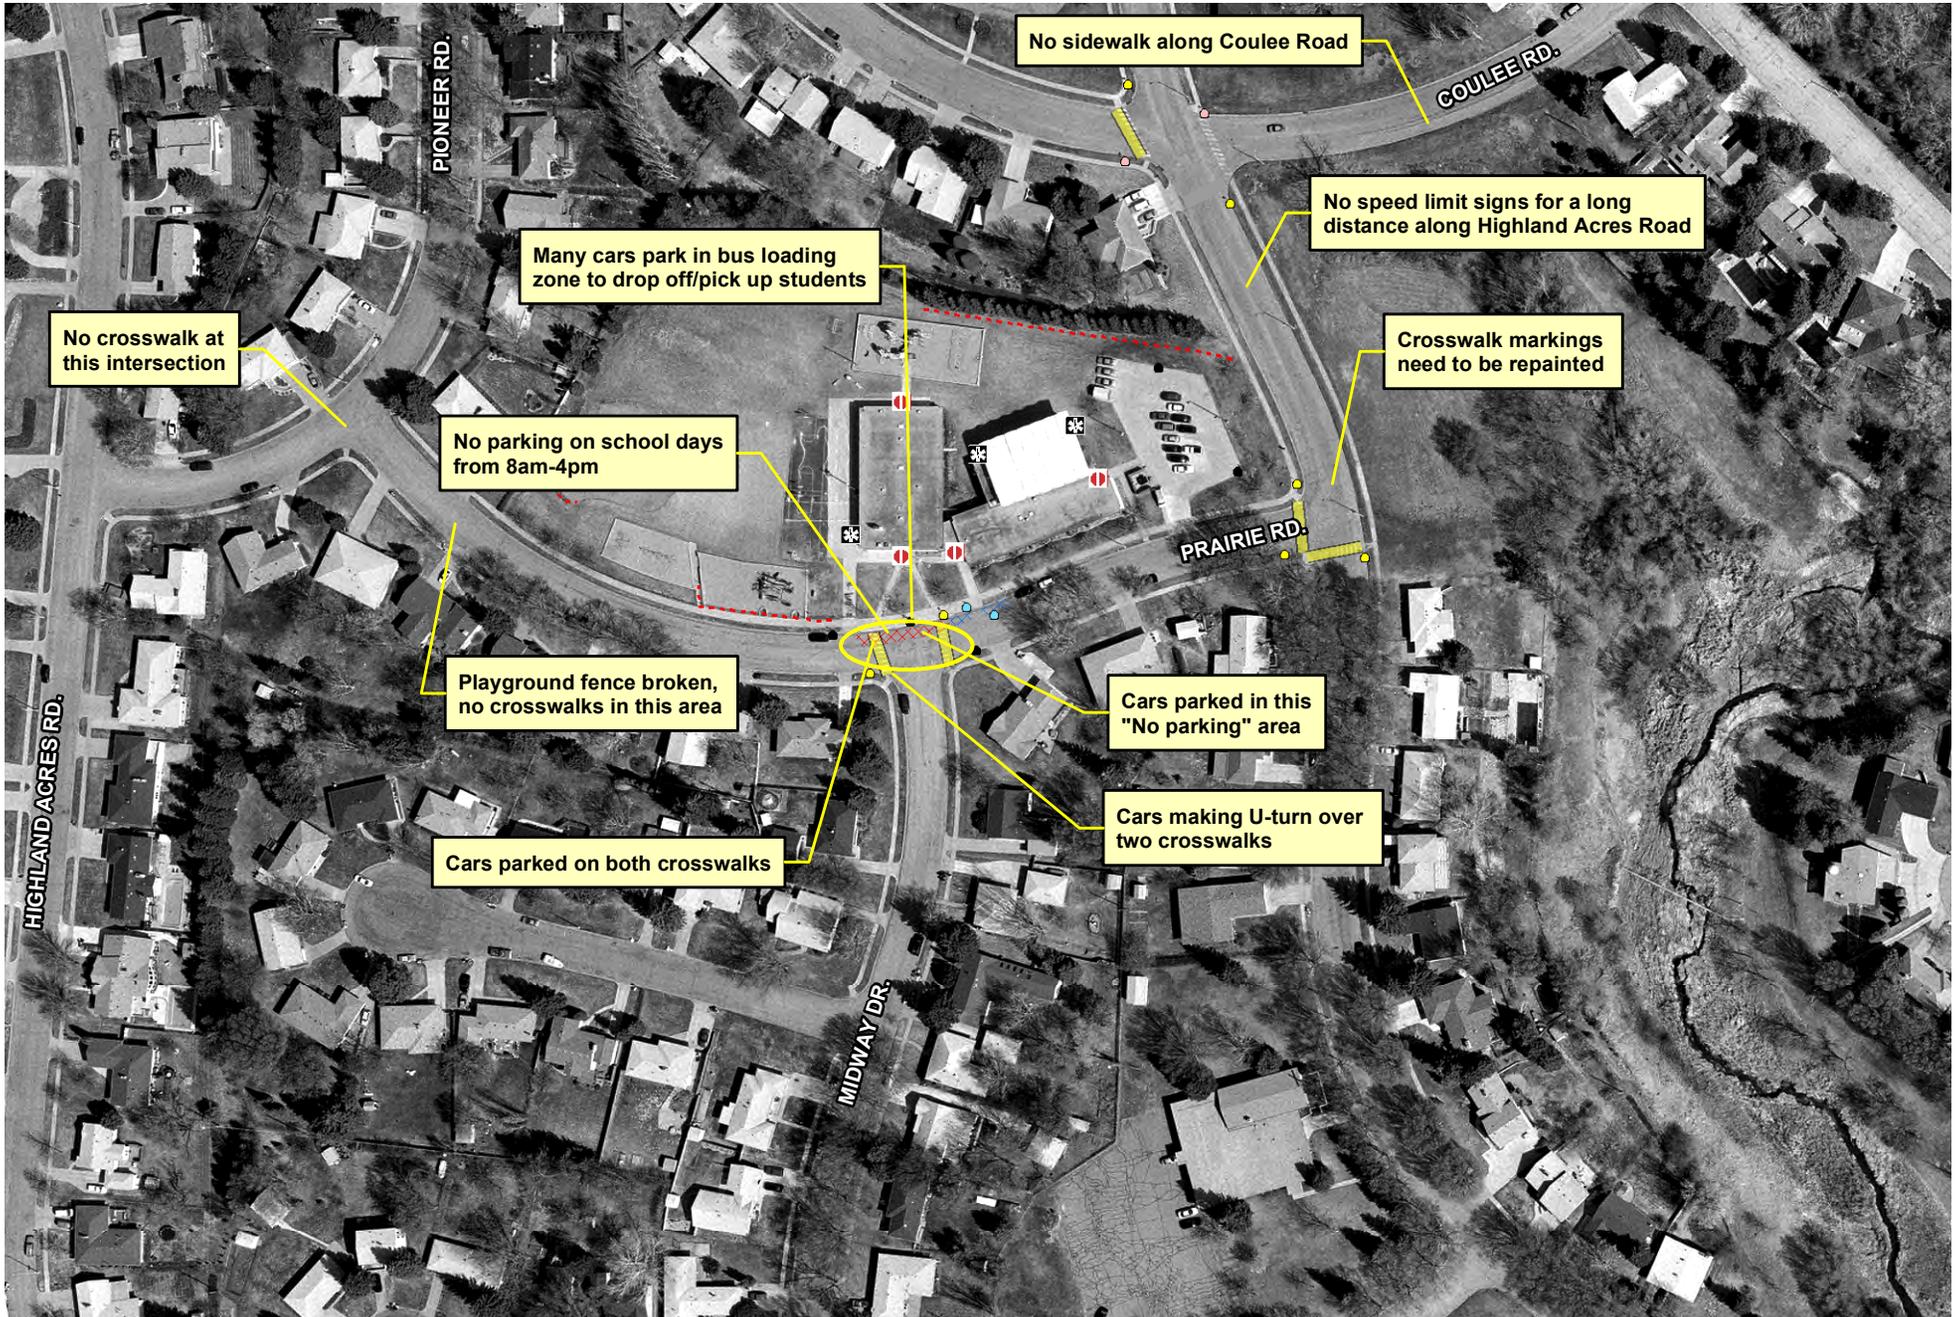
No sidewalk along Coulee Road

No speed limit signs for a long distance along Highland Acres Road

Playground fence broken, no crosswalks in this area

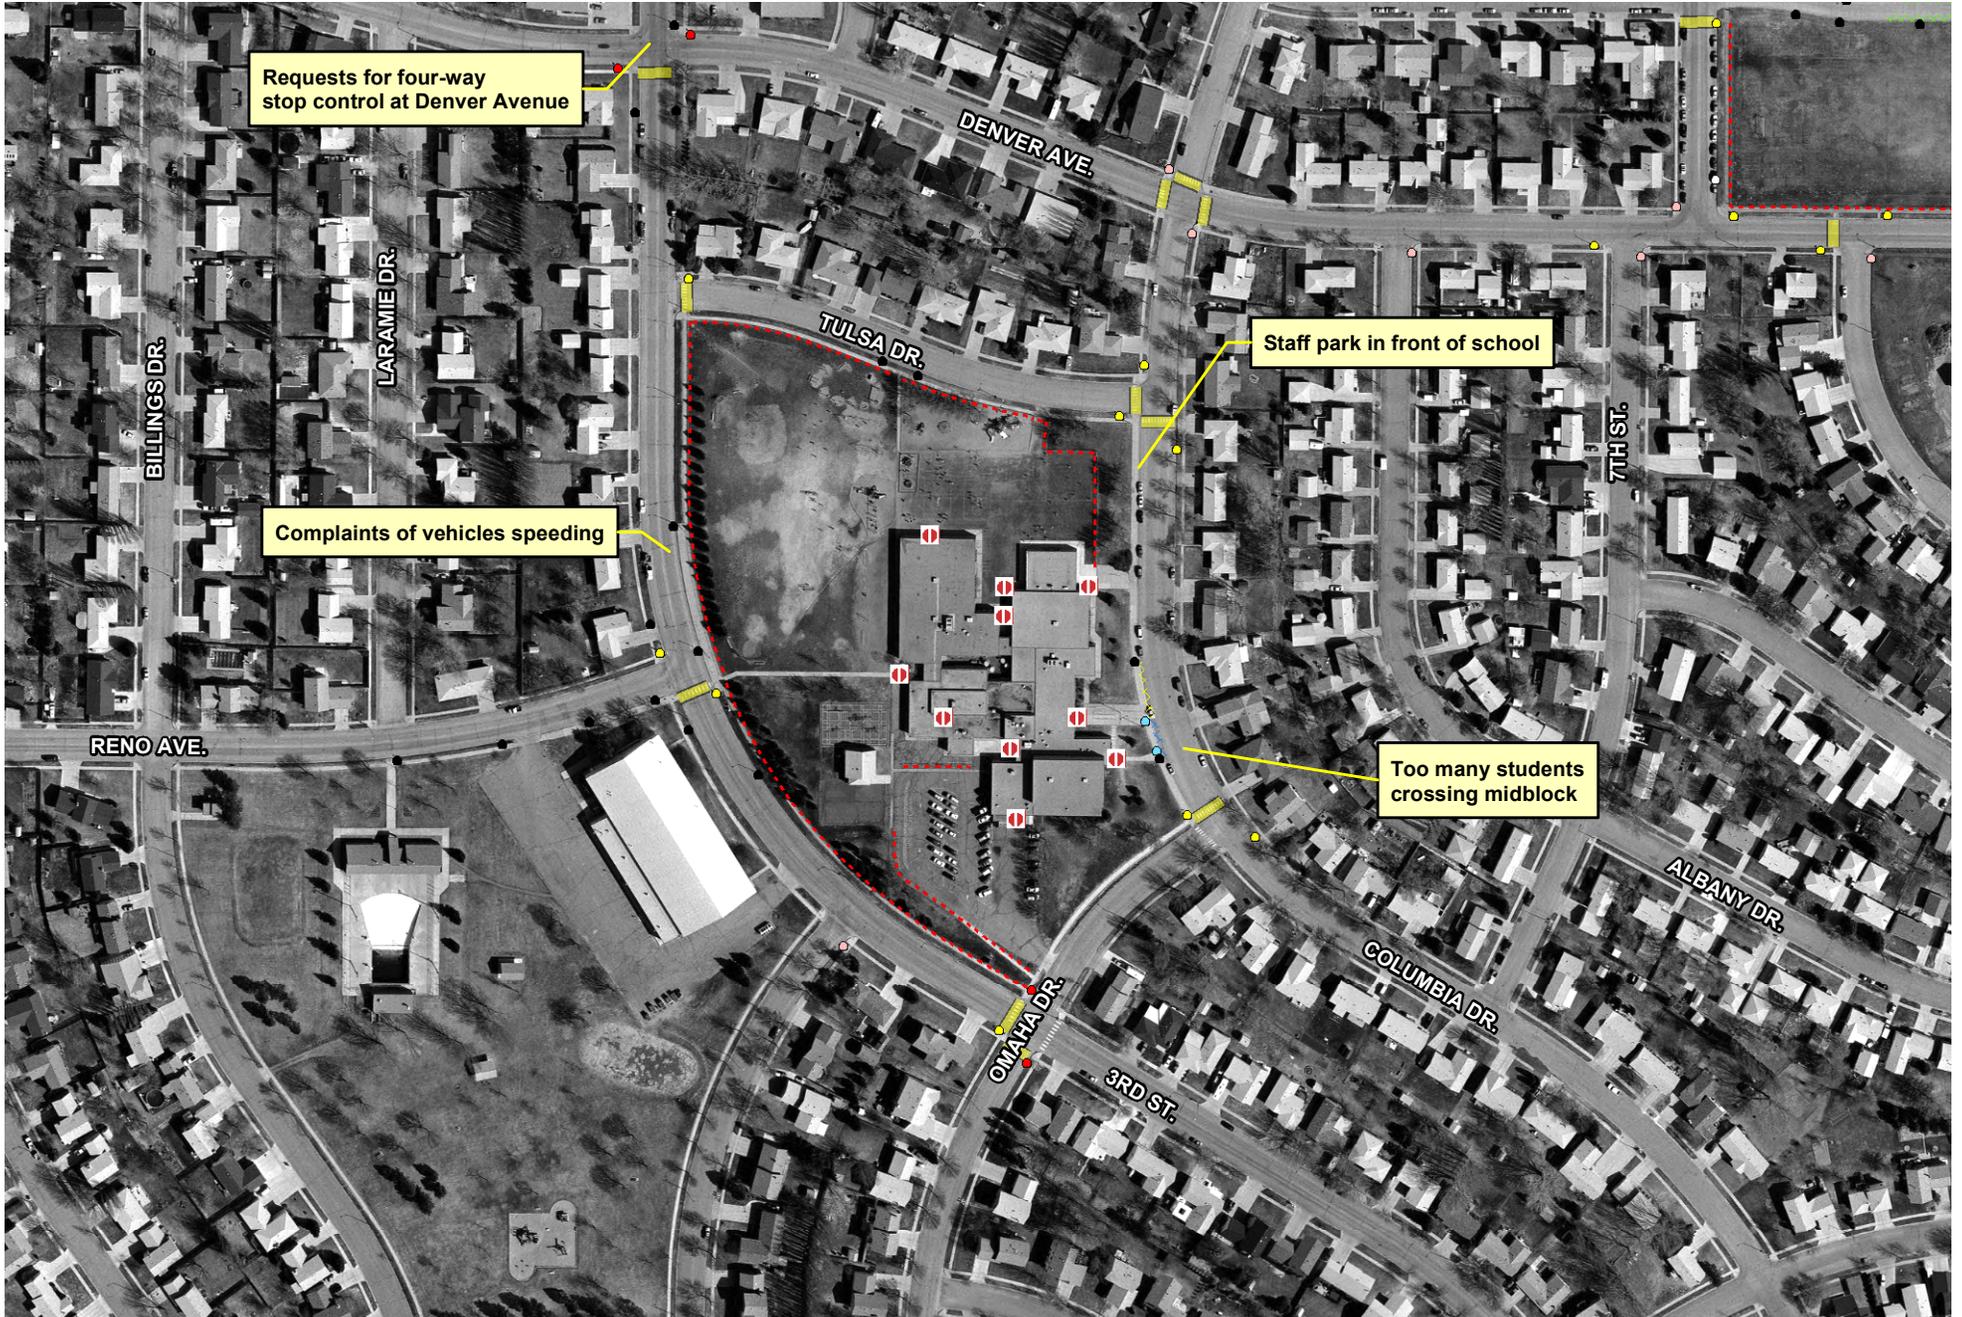
Requests for four-way stop control at Denver Avenue

Complaints of vehicles speeding

Staff park in front of school

Too many students crossing midblock

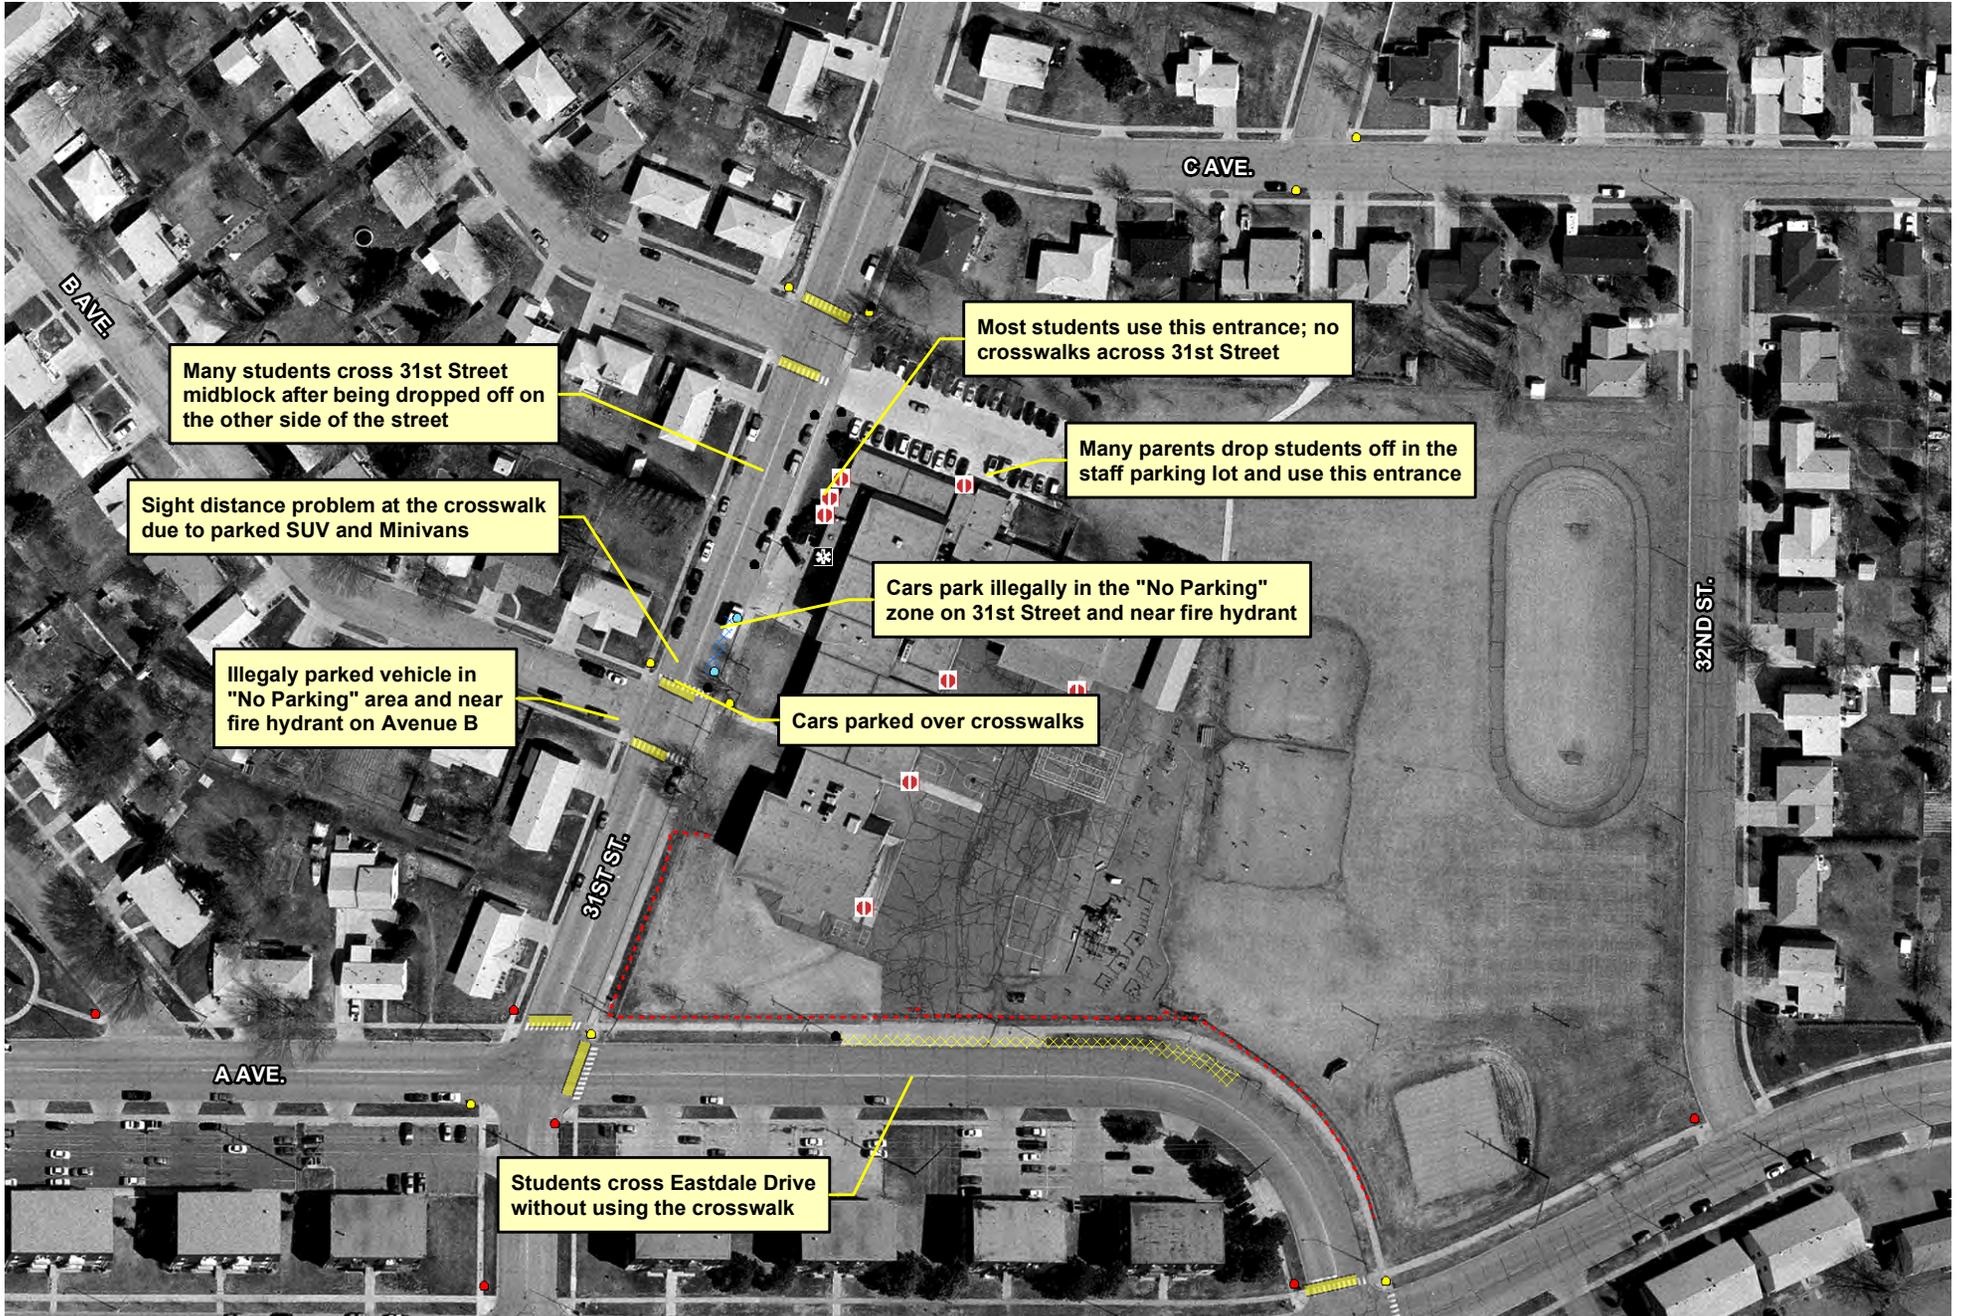
Many students cross 31st Street midblock after being dropped off on the other side of the street

Sight distance problem at the crosswalk due to parked SUV and Minivans

Cars parked over crosswalks

Students cross Eastdale Drive without using the crosswalk

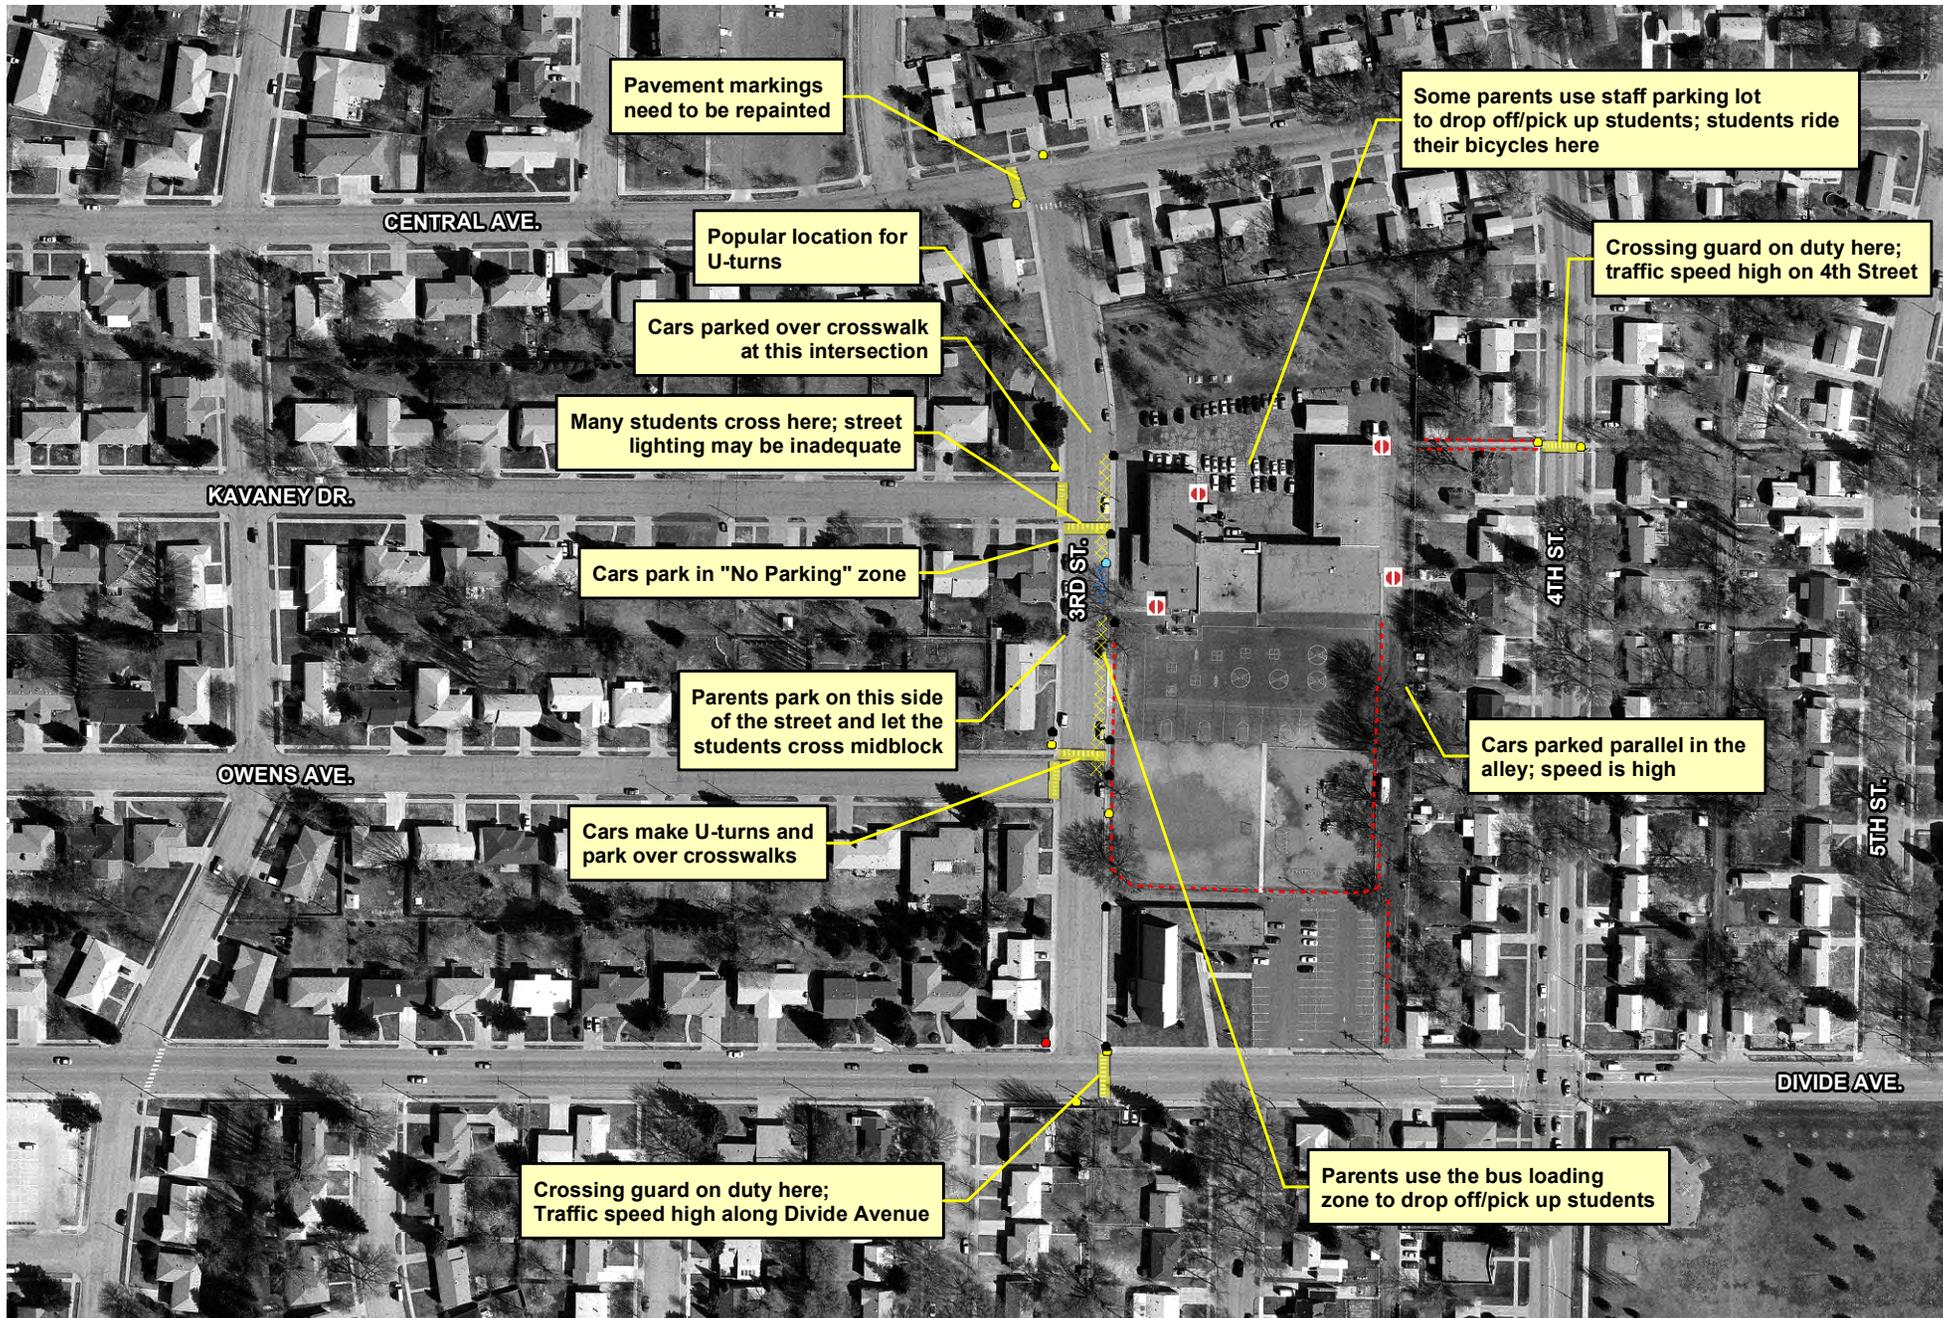
Pavement markings need to be repainted

Some parents use staff parking lot to drop off/pick up students; students ride their bicycles here

Many students cross here; street lighting may be inadequate

Parents use the bus loading zone to drop off/pick up students

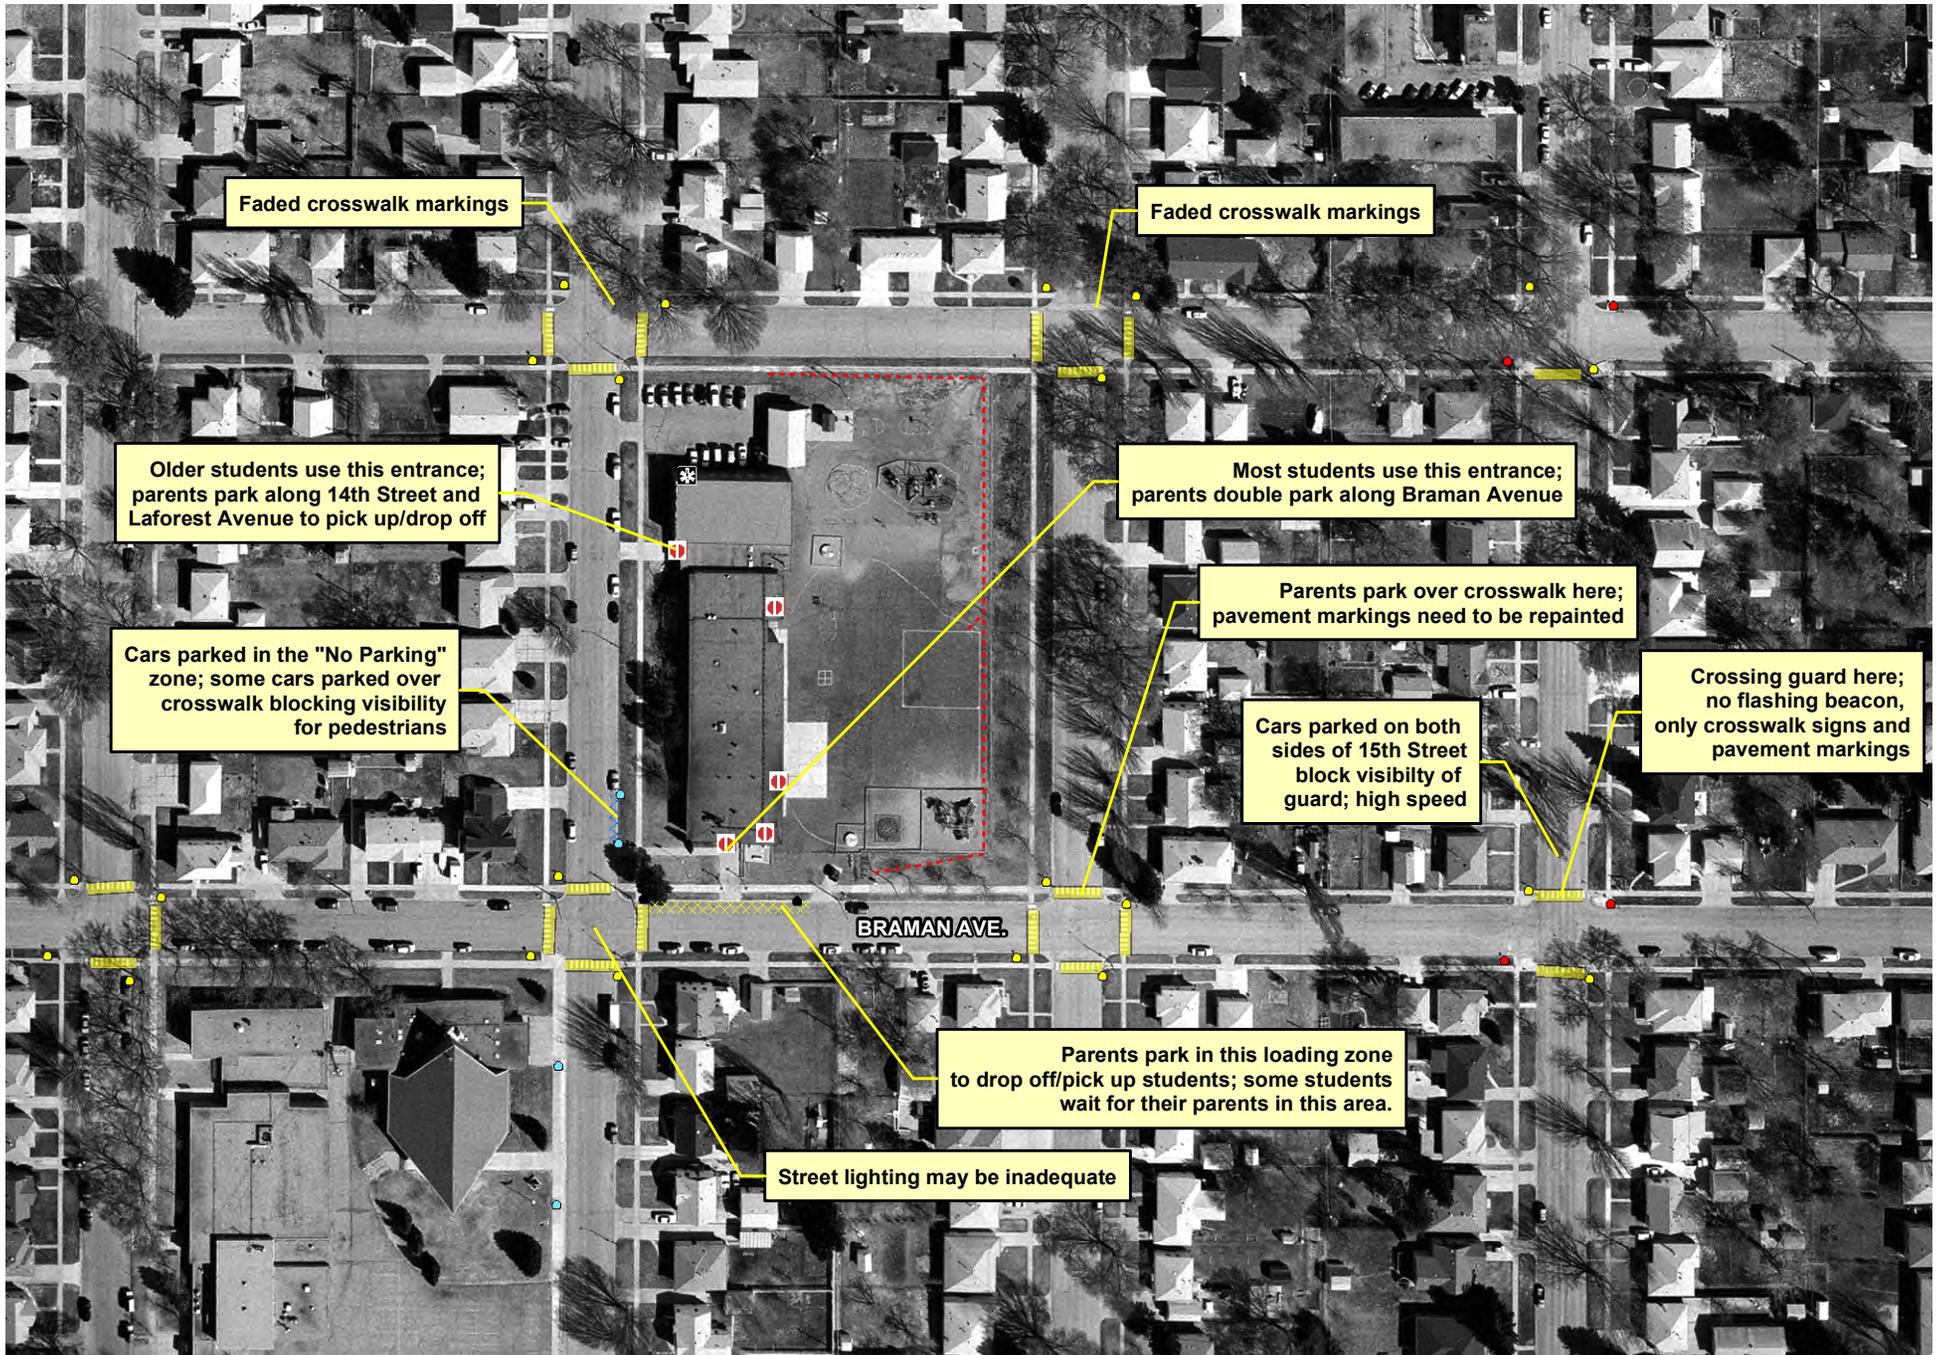
Faded crosswalk markings

Street lighting may be inadequate
