## BECEP at Richholt School

TALKED WITH: Michelle Hogan, BECEP at Richholt  
RECORDED BY: Donovan Slag  
PROJECT: School Crossing Study  
SUBJECT: School Crossing Issues  
DATE: October 21, 2004

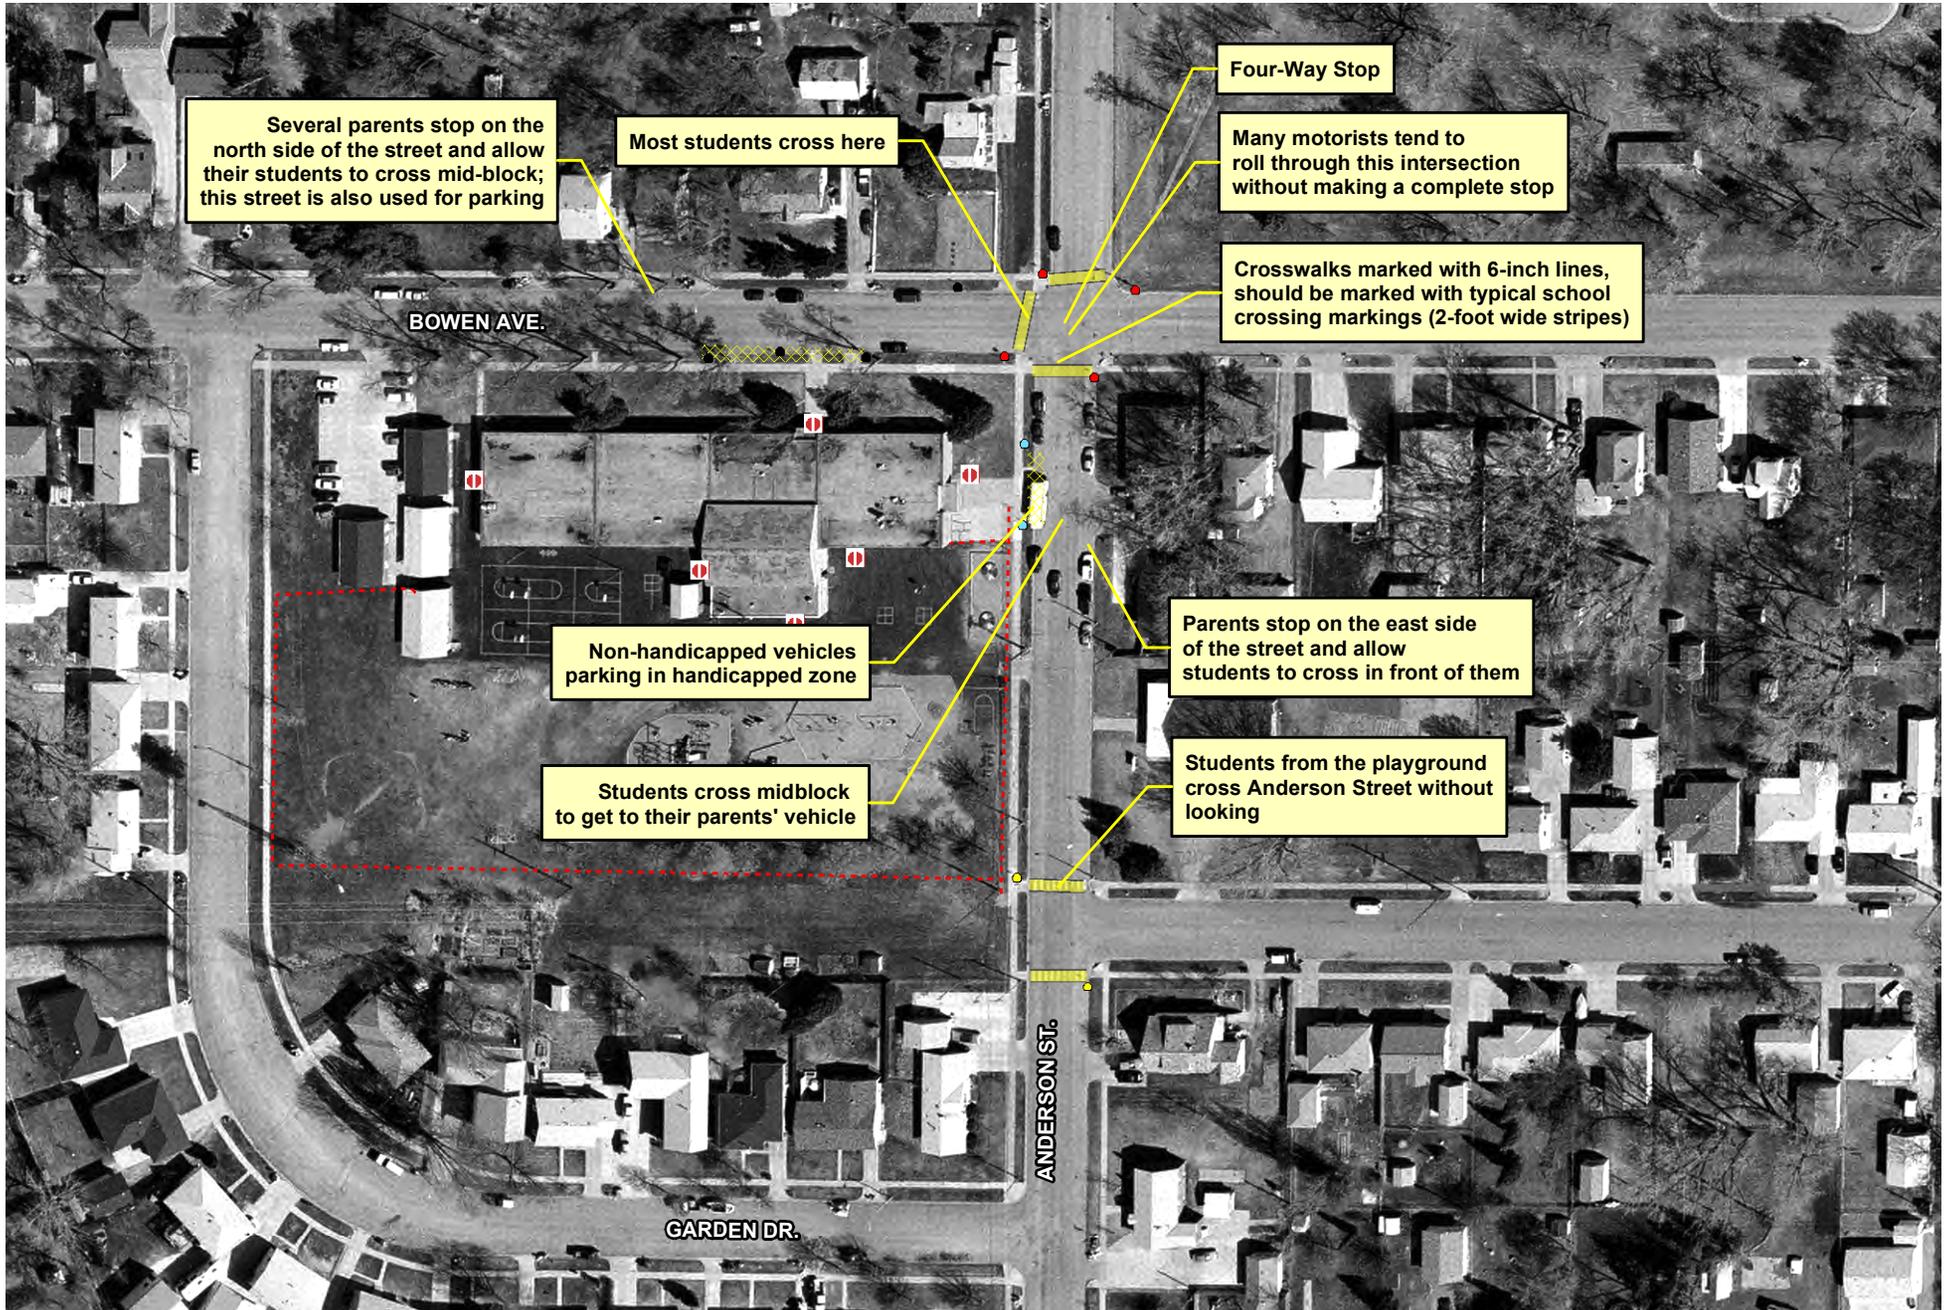
Several parents stop on the north side of the street and allow their students to cross mid-block; this street is also used for parking

Most students cross here

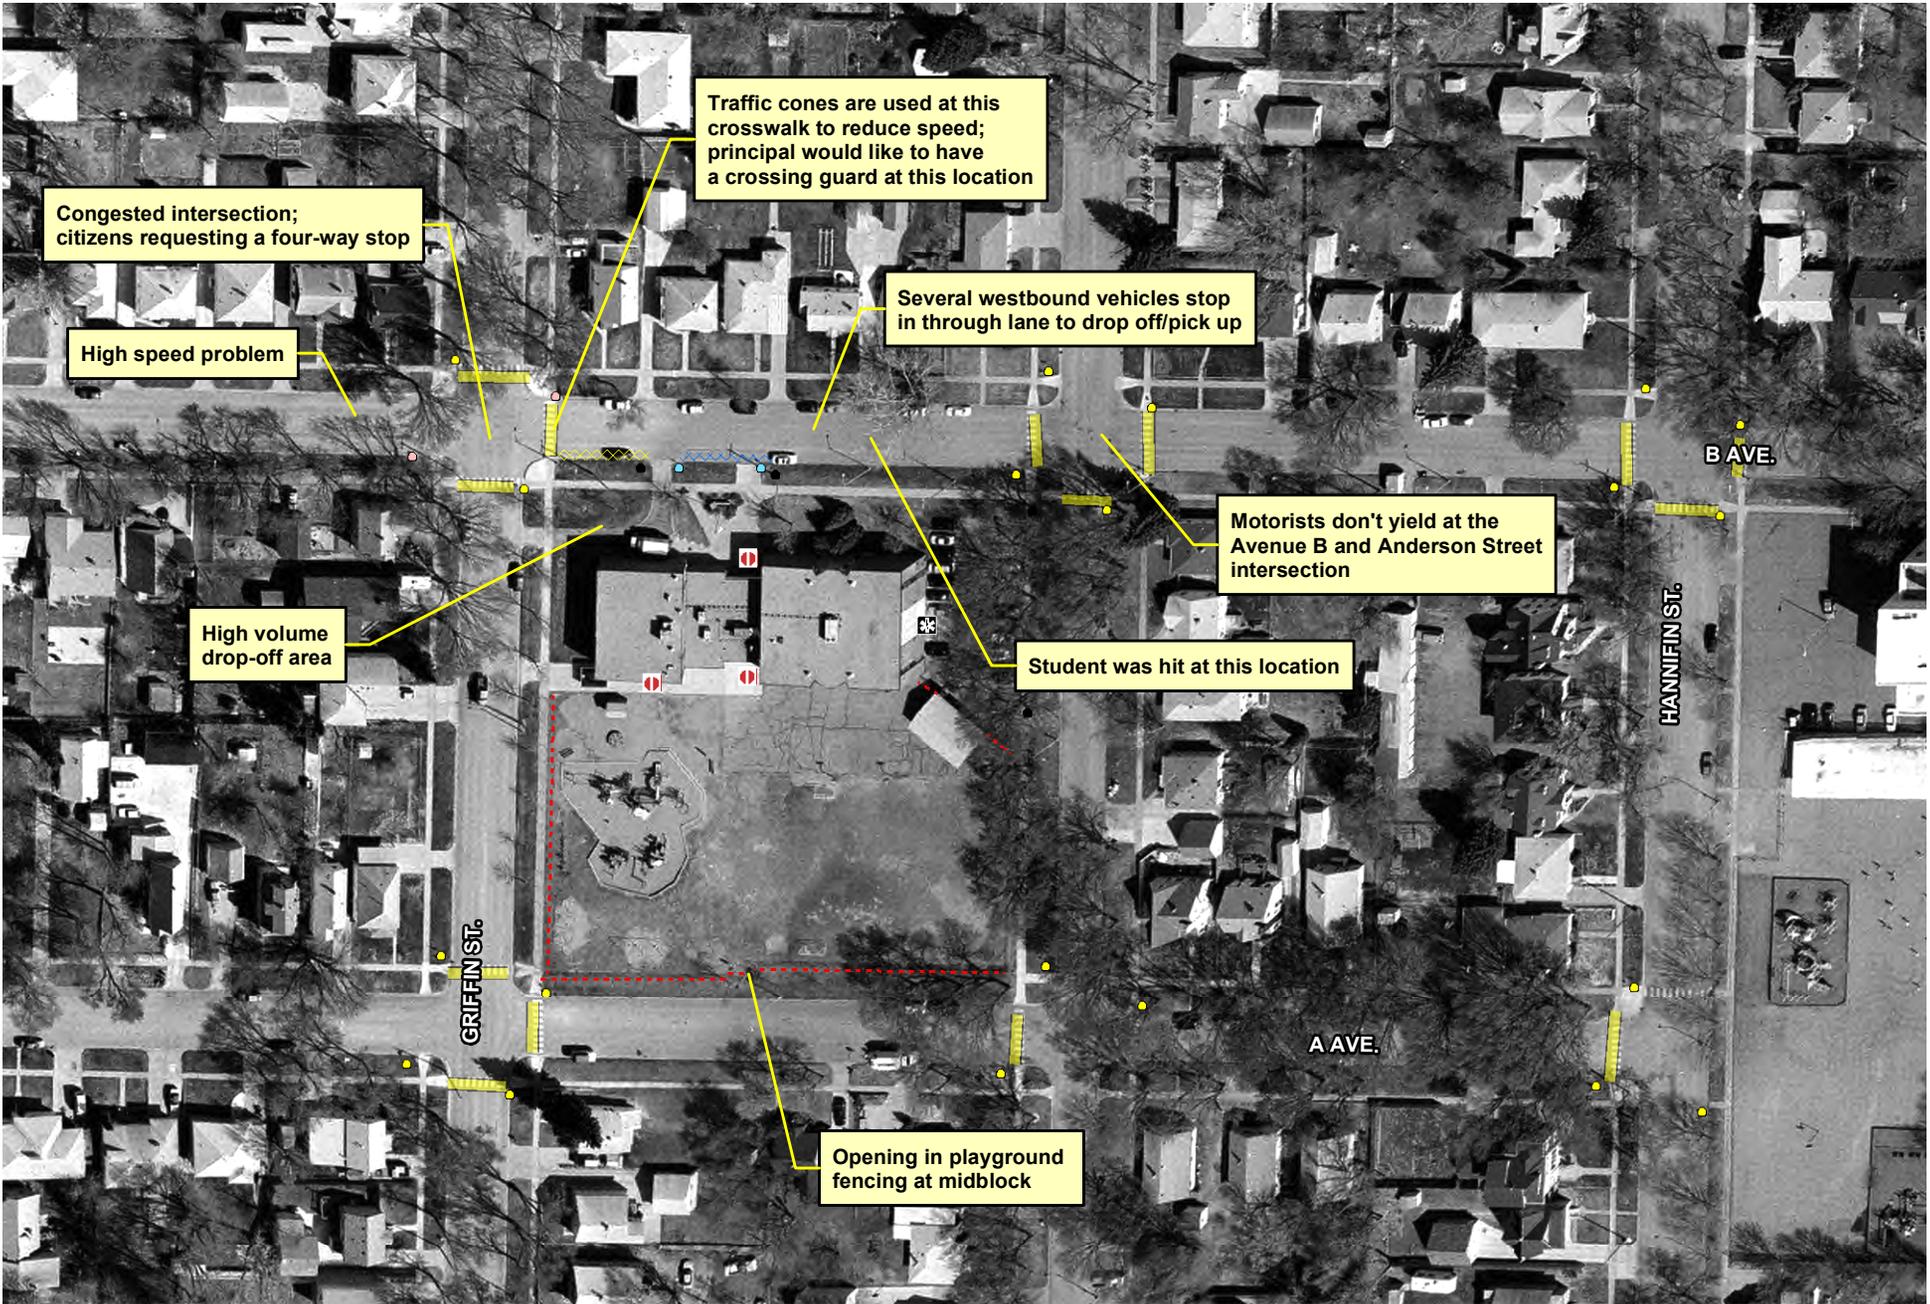
Congested intersection;  
citizens requesting a four-way stop

High speed problem

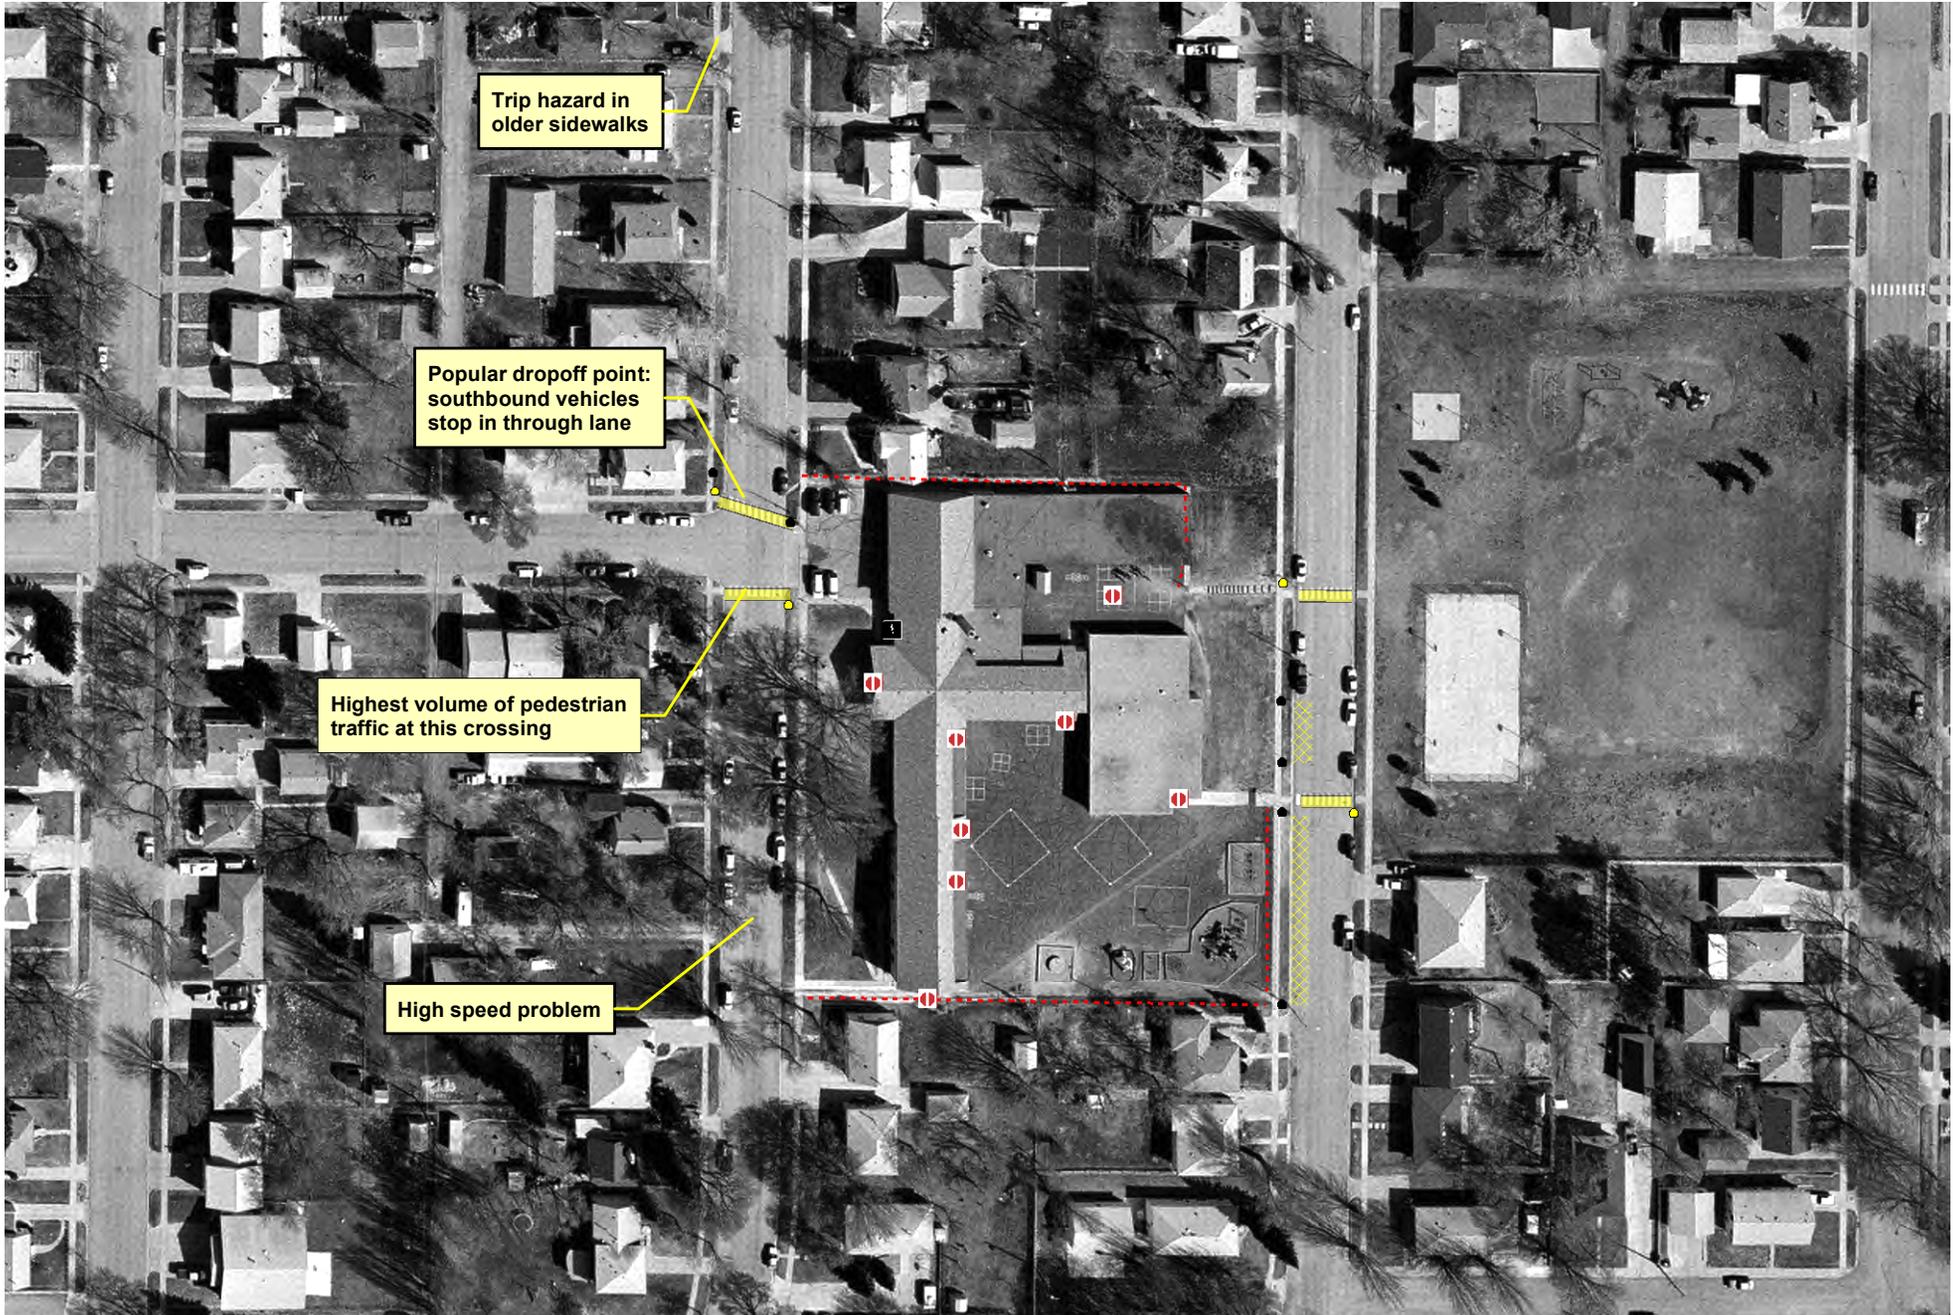
Trip hazard in older sidewalks

Popular dropoff point: southbound vehicles stop in through lane

Highest volume of pedestrian traffic at this crossing

High speed problem

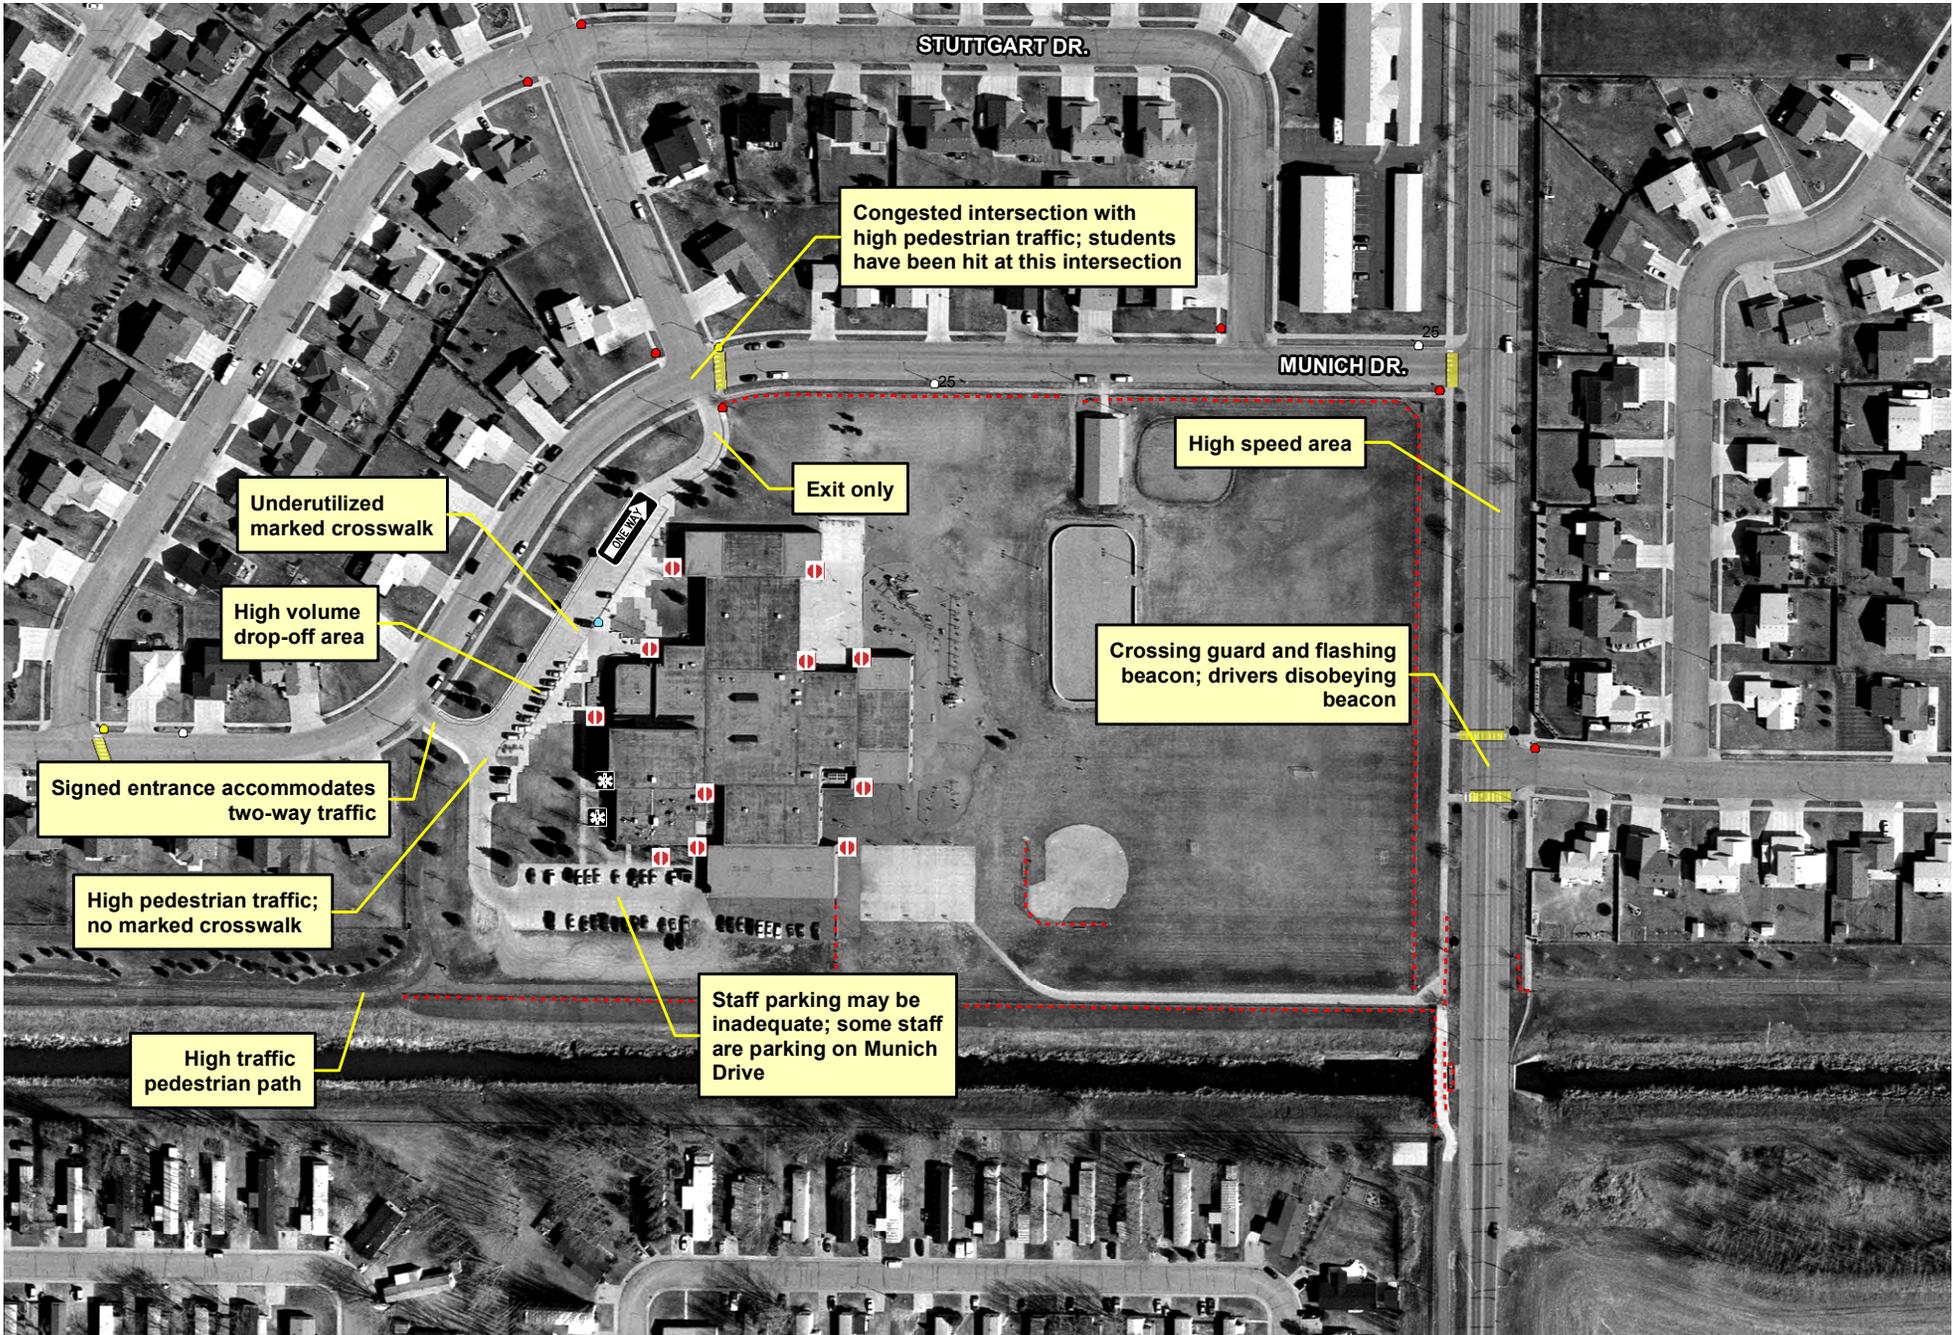
Congested intersection with high pedestrian traffic; students have been hit at this intersection

Staff parking may be inadequate; some staff are parking on Munich Drive

High traffic pedestrian path

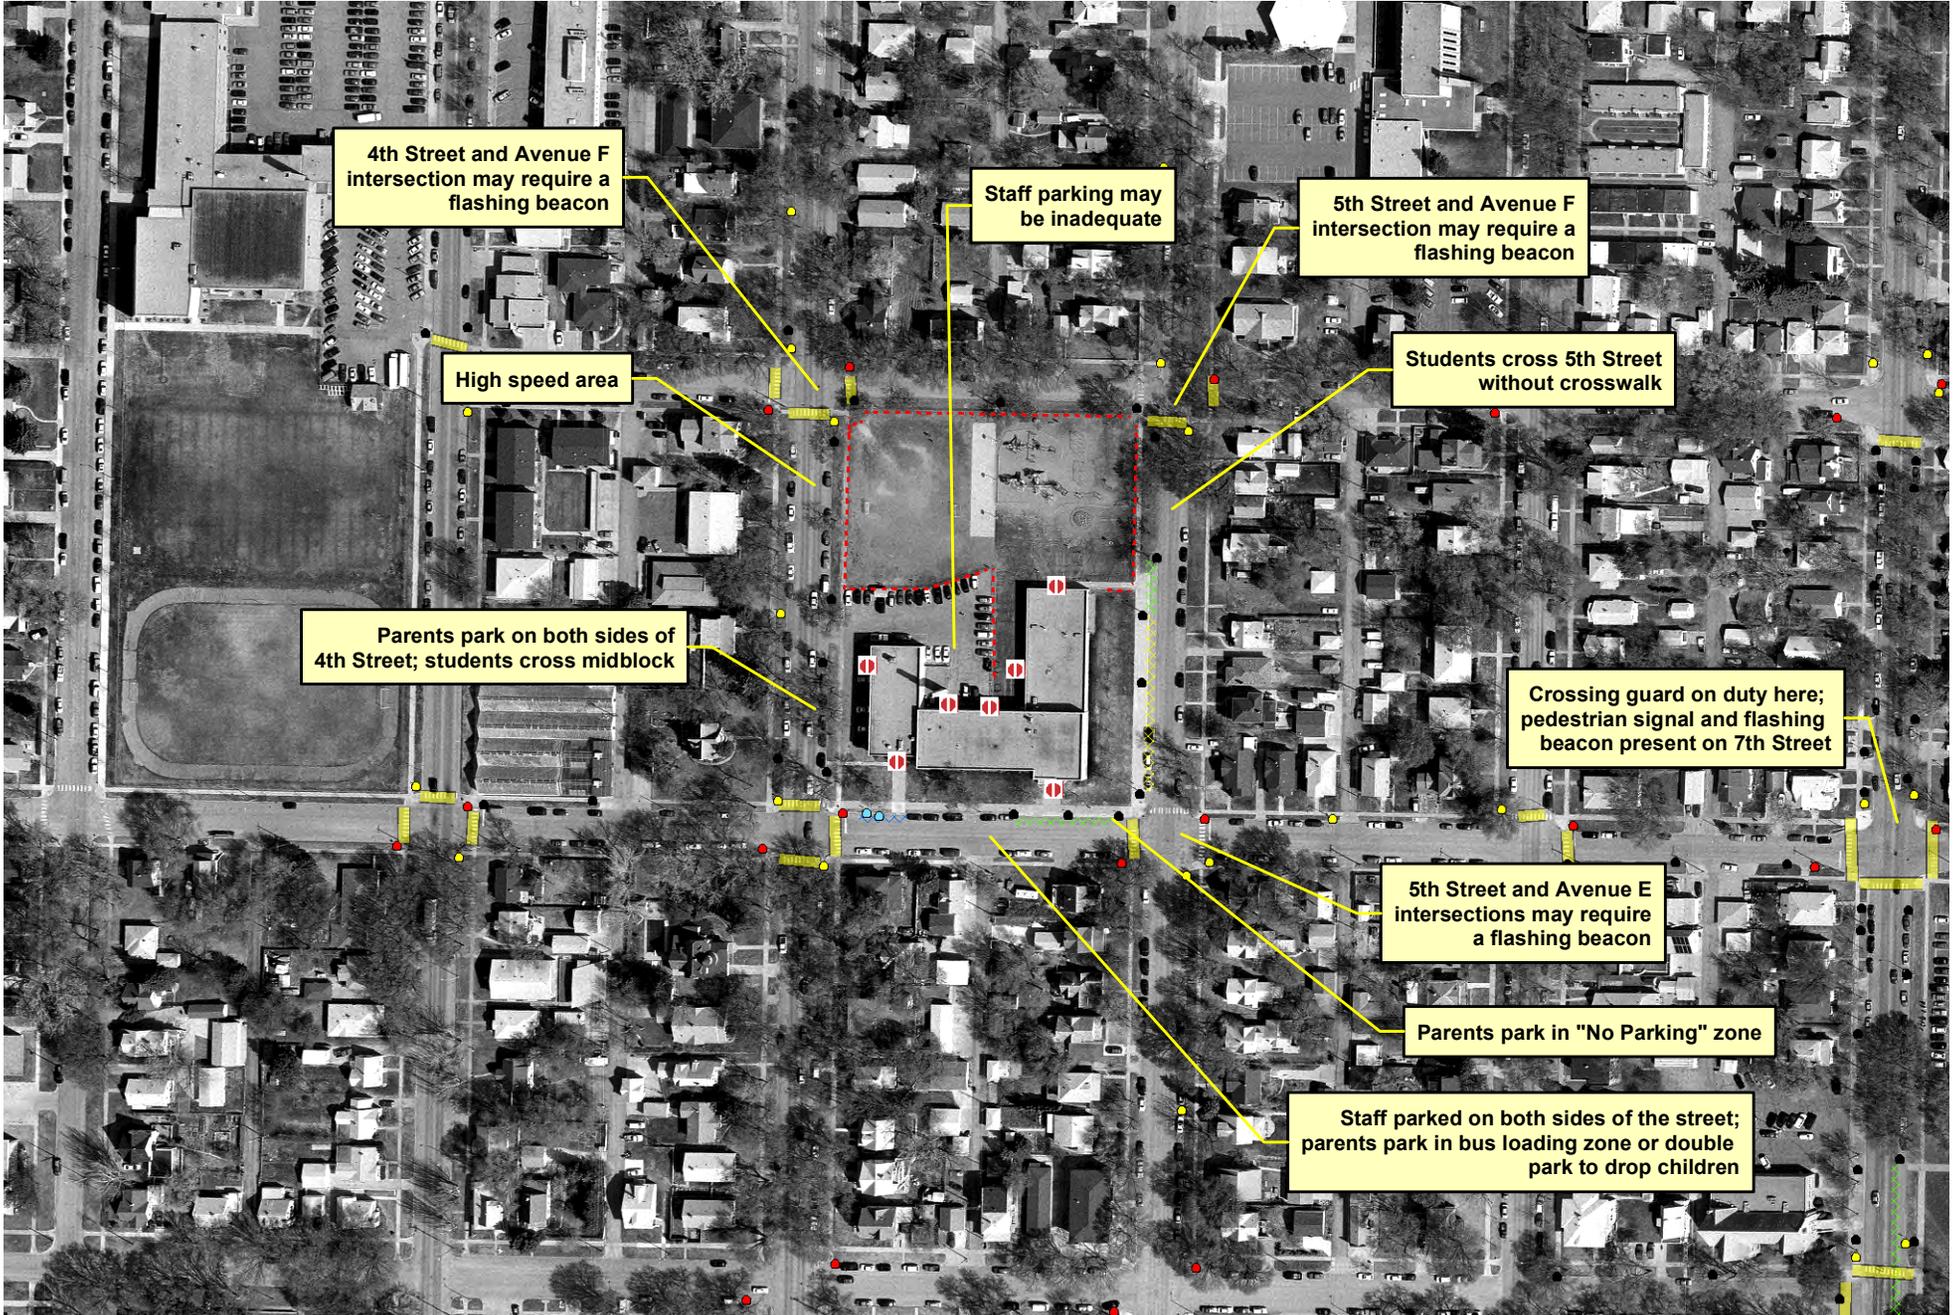
4th Street and Avenue F intersection may require a flashing beacon

Staff parking may be inadequate

High speed area
