**MicroPAVER Implementation and
Pavement Condition Index (PCI) Survey Project**

**State of the Streets Report
including
MicroPAVER Technical Documentation**

**Prepared for:
City of Bismarck, North Dakota**

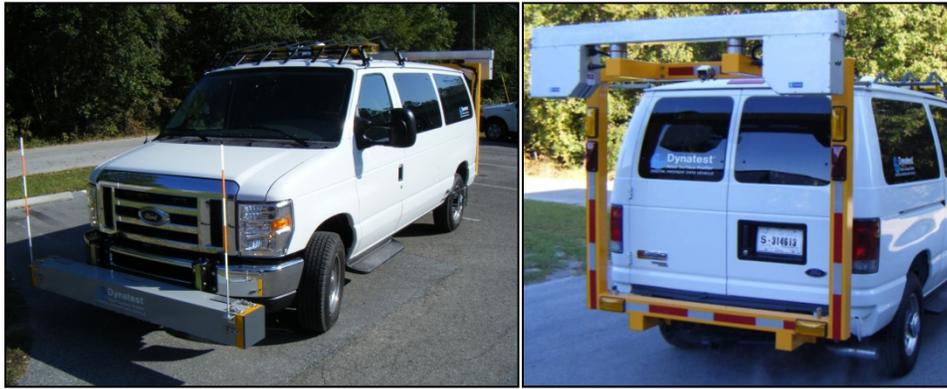
Figure 6: Dynatest Multi Function Vehicle

The downward imaging LRIS system is composed of two high resolution linescan cameras and lasers that are configured to continuously image 13ft wide lanes (4096 pixels) with 1mm crack width resolution at speeds up to 100 km/h (60 mph). This imaging system was designed to increase the contrast and visibility of both small longitudinal and lateral road cracks.

Downward images were collected in both directions of each of the City's two-way streets. For City streets with four or more lanes, downward images were collected in just two lanes, one in each direction of travel. A high-definition, forward-facing Panasonic digital video was used to collect ROW images at 20ft intervals along all of the City's streets.

The Dynatest Road Surface Profilometer (RSP) mounted on the MFV is designed to provide accurate and repeatable pavement profile data. Using seven (7) lasers and two (2) accelerometers, the RSP is capable of real-time, continuous, highway-speed, dual-wheel-path measurements of longitudinal profile, transverse profile, and rut depth. RSP data were collected for all of the City's streets and used in establishing PCI values for each pavement section. All imagery and profile measurements collected with the MFV as part of this project are referenced to a linear chainage and coordinates from a Differential Geographical Positioning System (DGPS). The MFV's integrated Trimble AG-132 receiver and Applanix POS LV systems were used for recording accurate DGPS coordinates.

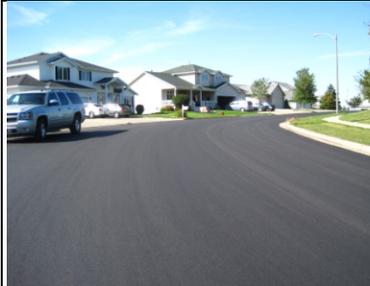
<p>Selkirk Rd. Section 5 <i>Between Colt Ave. and Huron Dr.</i></p>	<p>100</p>	<p>Do Nothing</p>

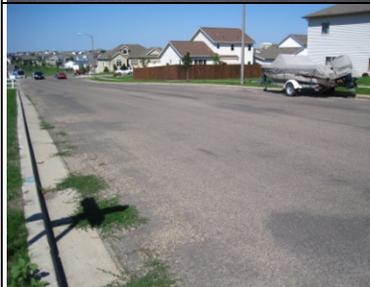
<p>Valley Dr. Section 50 <i>Between Mustang Dr. and Overland Rd.</i></p>	<p>92</p>	<p>Do Nothing or Preventive Maintenance <i>Surface Treatment</i></p>

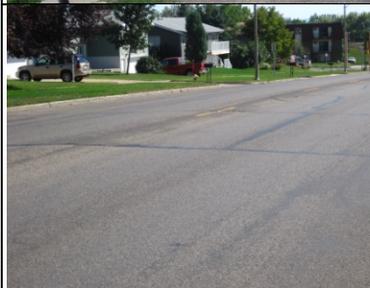
<p>Washington St. Section 325 <i>Between Juniper Dr. and Aspen Ave.</i></p>	<p>86</p>	<p>Preventive Maintenance <i>Crack Seal, Surface Treatment</i></p>

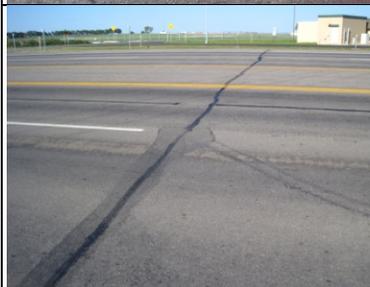
<p>University Dr. Section 10 <i>Between Yegen Rd. and Airport Rd.</i></p>	<p>79</p>	<p>Preventive Maintenance <i>Crack Seal, Localized Patching and Surface Treatment</i></p>

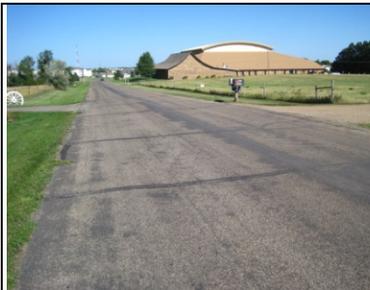
<p>Colt Ave. Section 10</p> <p><i>Between Selkirk Rd. and Washington St.</i></p>	77	<p>Preventive Maintenance <i>Crack Seal, Localized Patching, Surface Treatment</i></p>

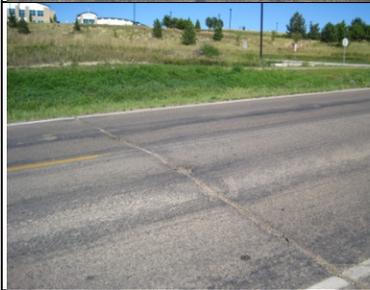
<p>Ash Coulee Dr. Section 70</p> <p><i>Between Valley Dr. and Mustang Dr.</i></p>	59	<p>Major M&R <i>Localized Structural Patching and Resurfacing</i></p>

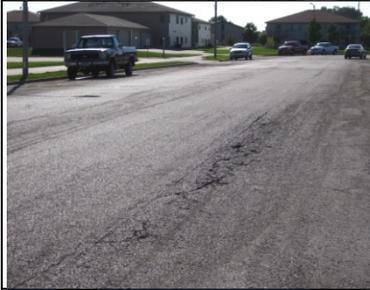
<p>Tacoma Ave. Section 10</p> <p><i>Between San Angelo Dr. and 12th St.</i></p>	53	<p>Major M&R <i>Localized Structural Patching and Resurfacing or Reconstruction</i></p>

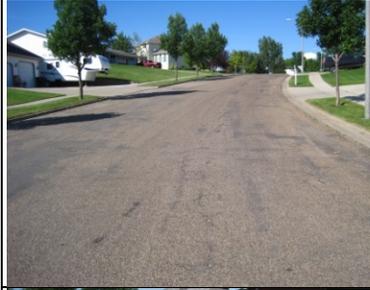
<p>Overlook Dr. Section 50</p> <p><i>Between Brunswick Dr. and Selkirk Rd.</i></p>	51	<p>Major M&R <i>Localized Structural Patching and Resurfacing or Reconstruction</i></p>

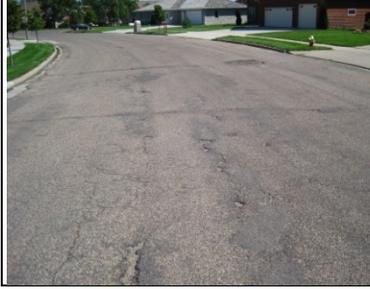
<p>Juniper Dr. Section 20</p> <p><i>Between Cherry Ln. and Washington St.</i></p>	45	<p>Major M&R <i>Localized Structural Patching and Resurfacing or Reconstruction</i></p>

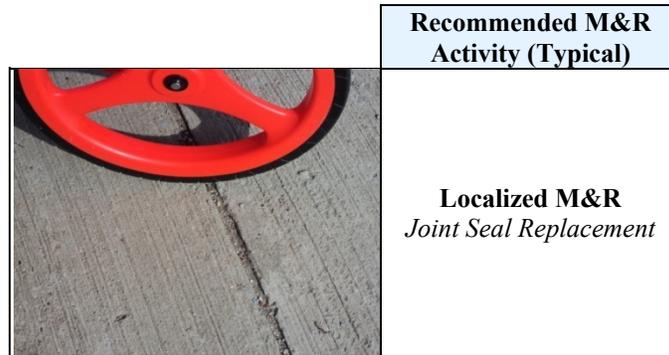
Figure 15: Deteriorated/Missing Joint Sealant between Concrete Slabs

A distress observed on many of the City’s concrete pavements was joint seal damage, as shown in Figure 15. Joint seal damage may be caused by several mechanisms, including: (1) thermal expansion of adjacent slabs during hot temperatures, which may cause the sealant to “pop out” of the joint and be dragged away

by traffic; and (2) oxidation of the sealant material, which may cause the sealant become brittle and debond from the joint.

Irrespective of the mechanism causing joint seal damage, the resulting unsealed (or partially sealed) joint may lead to premature deterioration and failure of the concrete pavement. For example, unsealed joints allow water to infiltrate into the underlying pavement structure, and the presence of water may significantly weaken the pavement structure and reduce the service life of the pavement. Furthermore, unsealed joints may become filled with incompressible materials such as loose stones. These incompressible materials may restrict the expansive movement of adjacent slabs and result in high compressive stresses in the concrete slabs. These compressive stresses may lead to spalling of the concrete and, in extreme cases, vaulting of adjacent slabs and slab “blowups.”

As the City continues to grow and add new pavements to its inventory, it is recommended that the City's preventive maintenance program be expanded to include concrete pavements, many of which lack functional joint sealant. The City's alley pavements should also be maintained in a manner similar to the roadway pavements.
