MANDAN BICYCLE FRIENDLINESS ASSESSMENT

FINAL REPORT OCTOBER 2025

PREPARED FOR:
BMMPO BICYCLE-PEDESTRIAN SUBCOMMITTEE

PREPARED BY:
STEPHEN LARSON
BISMARCK-MANDAN METROPOLITAN PLANNING ORGANIZATION
BISMARCK, ND

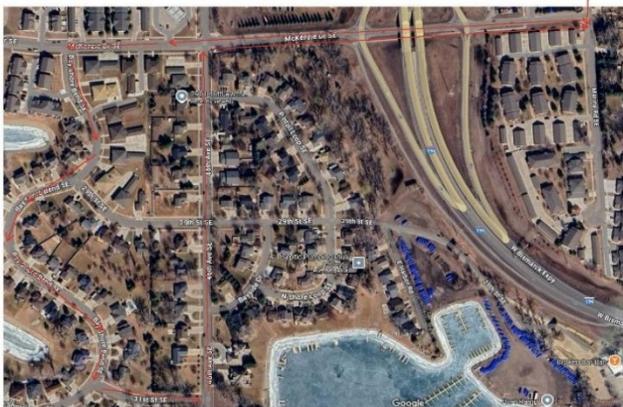
The route was selected for 2025 through discussion with participants in the May 2025 Bicycle Friendly Community Workshop and Bike Audit, highlighting a portion of the May Audit route for closer examination. The audit site runs along McKenzie Drive SE from Marina Road SE west to Bay Shore Bend SE, south along Bay Shore Bend to 31st Street SE, and north up 46th Avenue SE back to McKenzie. The larger area is near the Missouri River to the east, I-94 to the north, and the Heart River to the west. I-194/Expressway crosses McKenzie as an interchange and feeds

into the Memorial Bridge to the north and the Expressway Bridge to the south. The Memorial Bridge and Expressway Bridge are both significant traffic generators in this area. The area north of McKenzie Drive features a number of different businesses, including some very near the riverfront (such as the Paddle Trap and Moritz Sport and Marine), along with Raging Rivers Waterpark. There are also some large apartment complexes in this region. South of McKenzie is primarily comprised of

The point of beginning for the bike audit route was at the intersection of McKenzie and Marina Road. The route included approximately 1.5 miles to assess, which was divided into three segments (including 5 intersections). (*See map, page 1.*)

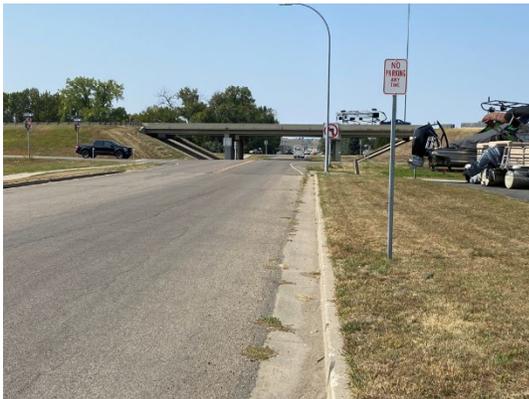
The roadway comprising this segment is bi-directional with two driving lanes. The speed limit is 25mph (one auditor noted drivers seemed not to be following the limit). Traffic exiting Expressway via the interchange from either the north or south is governed by stop signs. The intersection of McKenzie and 46th is governed by an all-way stop sign. There is no sidewalk on the north side of McKenzie from Marina Road until 46th Avenue.

There is sidewalk on the south side of McKenzie from the west entrance to Moritz Sport and Marine until the western leg of the interchange and connects into a shared-use path running from Expressway to 46th. There is no sidewalk on either

side of the street between the western and eastern entrances to Moritz Sport and Marine on McKenzie.

Considerations for bicycle-pedestrian improvements for this segment should include, at minimum, new crosswalk markings at McKenzie and 46th, and pedestrian infrastructure installation along the north side of McKenzie (a shared-use path would likely be the best utilization of the limited space).

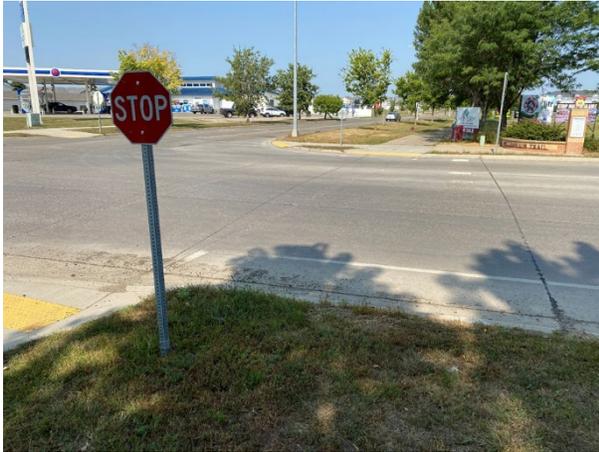
ADA ramps and marked crossings are provided on the south side of McKenzie for both legs of the interchange, but not on the north side. There are also ADA ramps and marked crossings on all four sides of the McKenzie and 46th Avenue intersection. However, there are no bicycle lanes provided on McKenzie, and the roadway/shoulder is narrow, particularly near the interchange (*photo, above*). The pedestrian crossings at McKenzie and 46th have significantly faded (*photo, page 4*). Auditors noted this segment is uncomfortable for cyclists and would be especially so during peak traffic times.

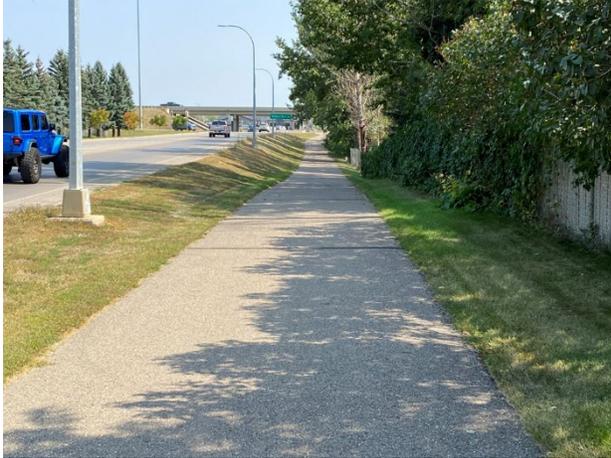
The roadway comprising this segment is bi-directional with two driving lanes. The speed limit is 25mph. There are sidewalks on both sides of 46th Avenue up to McKenzie, although the narrowness of the sidewalks was observed by auditors. The street along 46th is also narrow, so that vehicles driving by the auditors had to cross the centerline to give them space (something that would be difficult during peak traffic times). The intersection of McKenzie and 46th is governed by an all-way stop sign and has pedestrian crossings (although these are significantly

faded, as noted under the first segment). A shared-use path (in good condition) runs on the south side of McKenzie from 46th to the western leg of the Expressway interchange (where it then turns south to the Expressway Bridge), allowing cyclists to comfortably ride off-road (*photo, left*). Traffic exiting Expressway from either the north or south is governed by stop signs. There is sidewalk on the south side of McKenzie from the west leg of the interchange until the

western entrance into Moritz Sport and Marine, near to Marina Road, where it abruptly ends. There is no sidewalk provided along the rest of McKenzie until it restarts at Marina Road going south; as mentioned under the first segment, the roadway is narrow.

Considerations for bicycle-pedestrian improvements for this segment should include, at minimum, the improvements noted along the first segment, along with considerations for a wider sidewalk on one or

both sides of 46th Avenue, pedestrian lighting at the Expressway interchange (where auditors noted nighttime riding would be an issue), and an extension of the shared-used path on the south side of McKenzie past the interchange up to Marina (which would also close the sidewalk gap). Bike lanes could also be considered here, but a path extension may be more appropriate to address the gaps in infrastructure in this area, especially given the existing trail.

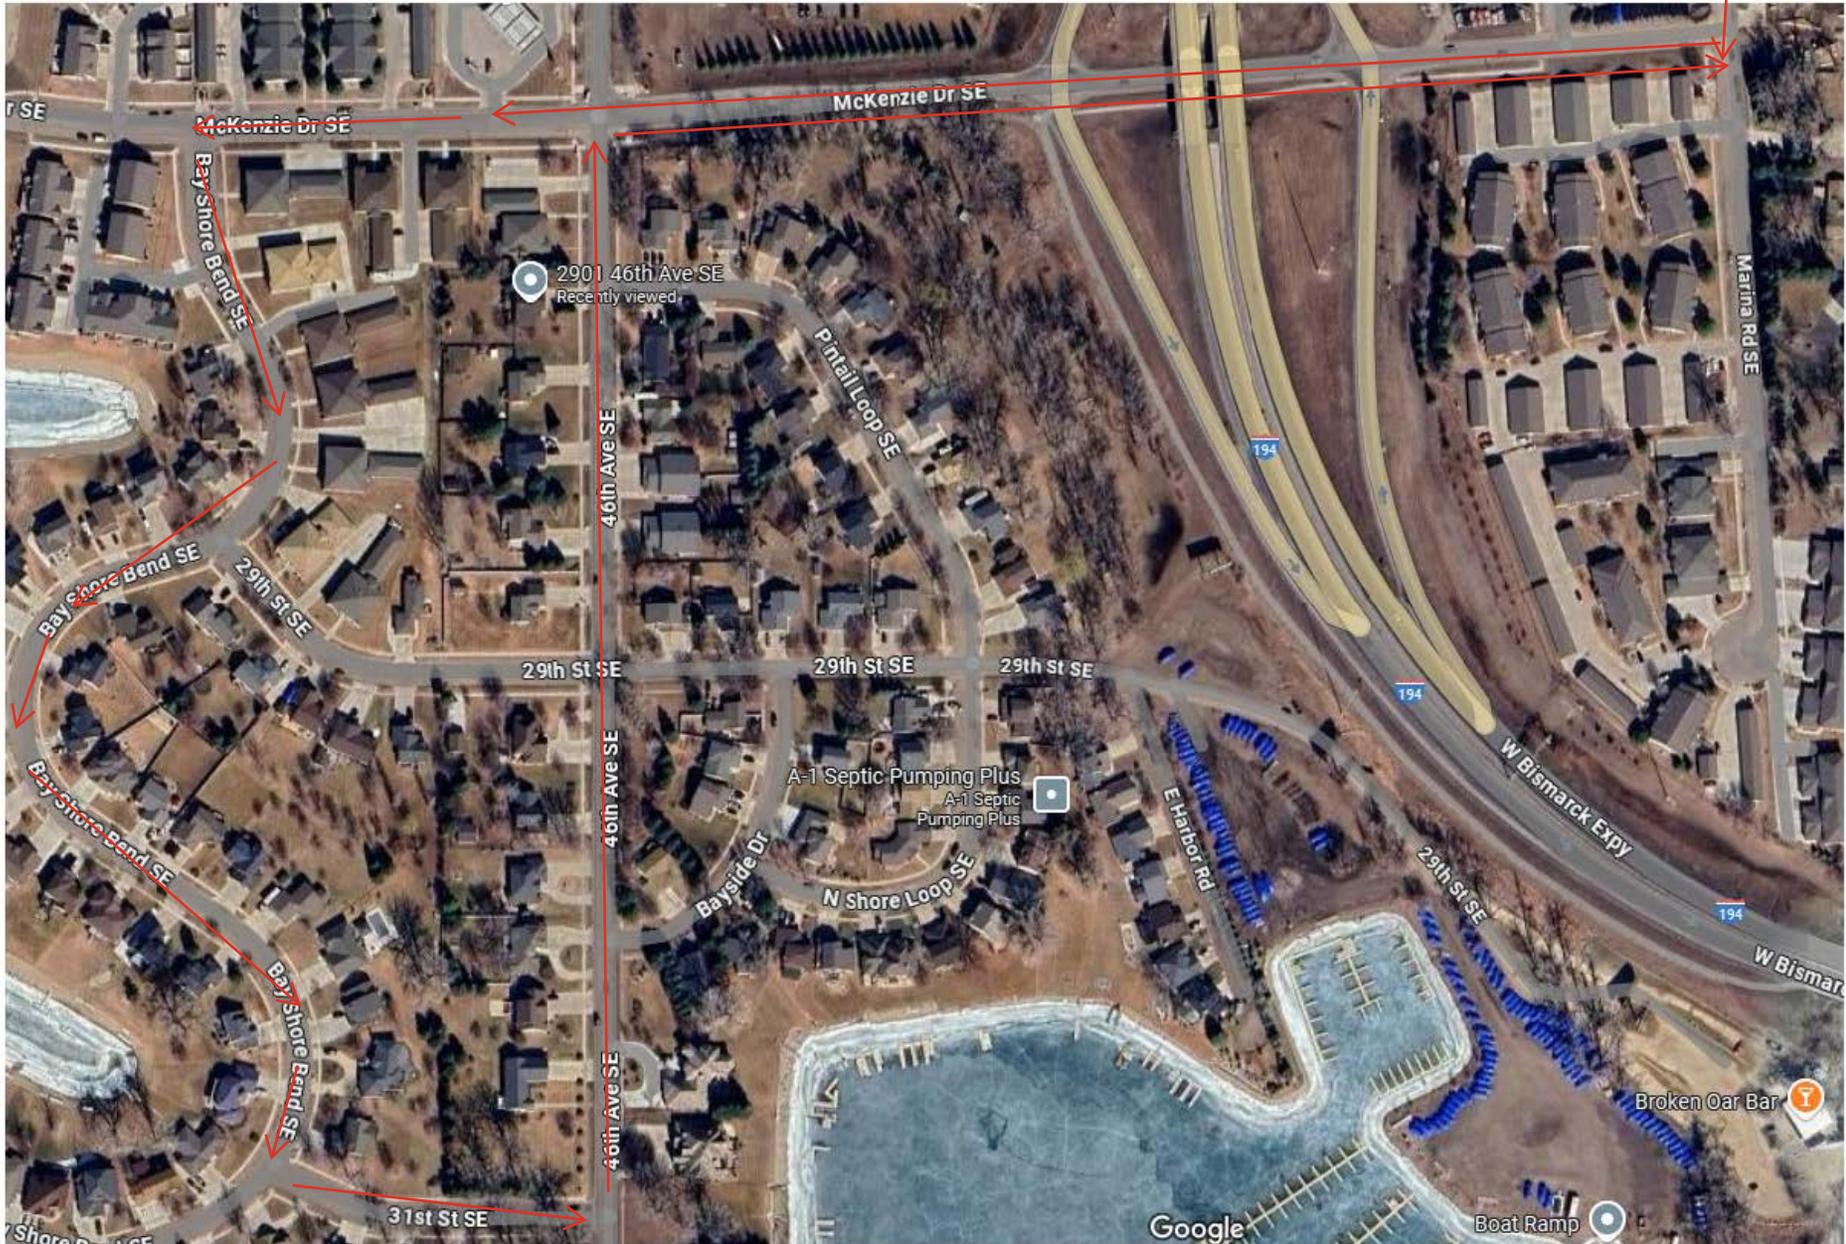
Mandan Bike Audit Route, September 2025.

Start at Marina Road SE, ride west on McKenzie Drive SE to ARCO Station just past 46th Ave SE. After pause, resume riding west on McKenzie to Bay Shore Bend SE, ride on Bay Shore south to 31st Street SE, and east on 31st to 46th Ave. Pause, then ride north on 46th, and east on McKenzie until you reach your starting point again at Marina Road.
