# Treatment of Historic Properties

*Note: The majority of the information provided below is based on information found on the National Park Service's Secretary of the Interior's Standards for the Treatment of Historic Properties online guides and website. This guide is only meant to condense this information as it relates to this community.*

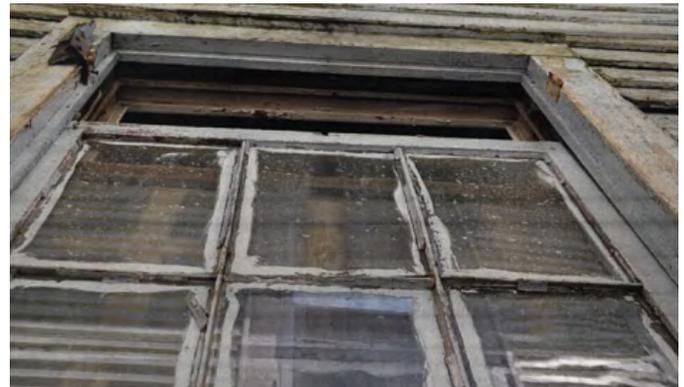
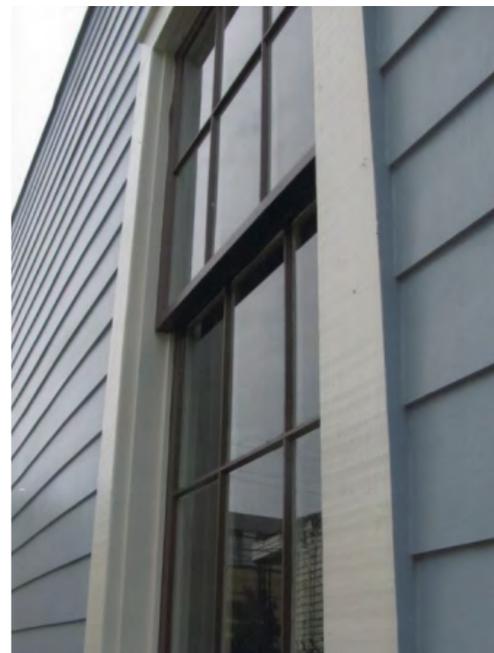
**DO.** This deteriorated historic wood window was repaired and retained ([Secretary of the Interior's Rehabilitation Standards](#), p. 108).

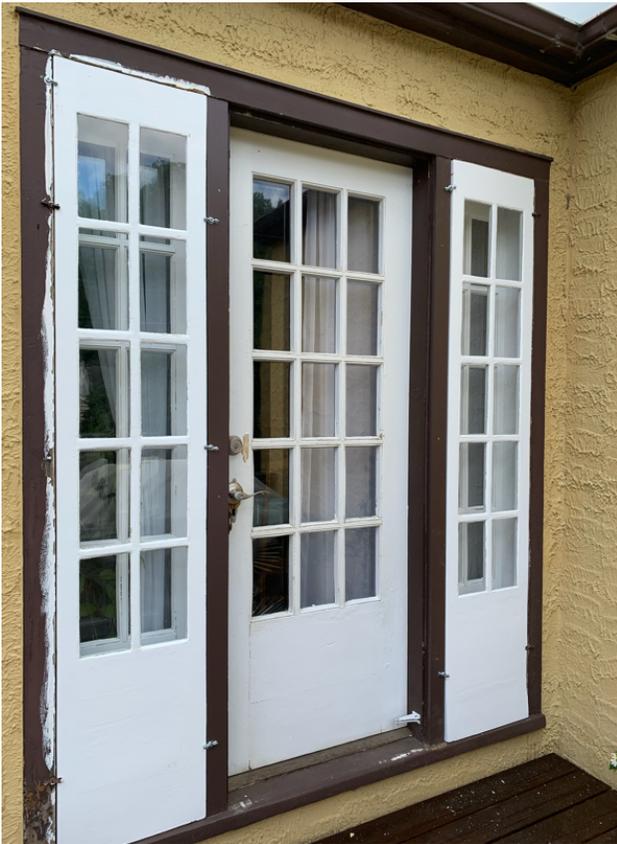
**DO.** The owner of this house in Bismarck's Cathedral District restored the windows on this front door which included scraping, chipping out the old glazing, replacing broken panes, and then re-glazing and re-installing.

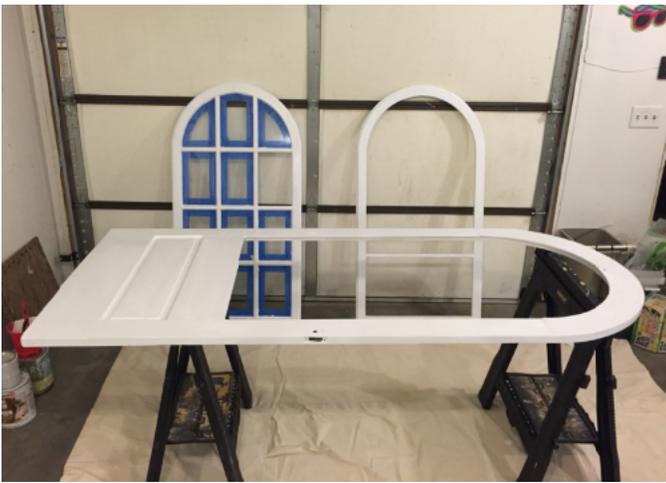
**DO.** The owner of this house in Bismarck's Cathedral District restored the windows in the back as well as rehabilitating this front door.

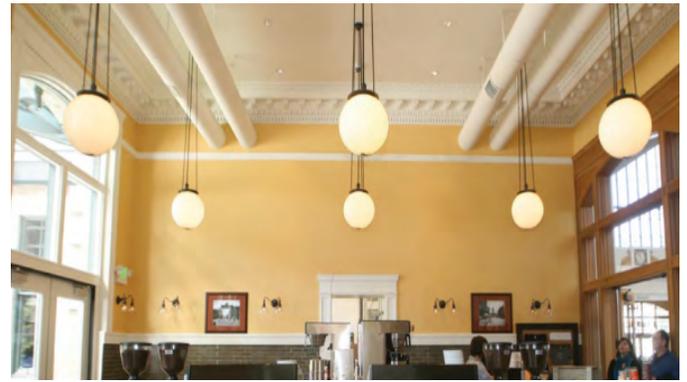
**DO.** After considering other options that would have damaged or obscured the ornamental plaster crown molding, the owners decided to paint and leave the ducts exposed while still making sure it was as compatible as possible ([Secretary of the Interior's Rehabilitation Standards](#), p. 132).

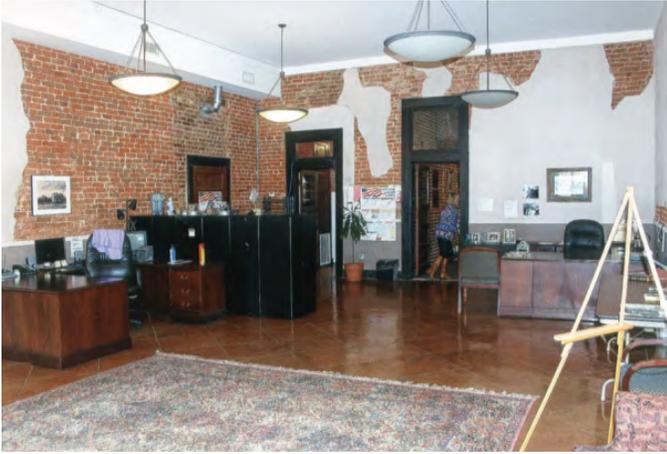
**DON'T.** This has fragments of deteriorated or “sculpted” plaster that is not a compatible treatment for either finished or unfinished interior spaces ([Secretary of the Interior’s Rehabilitation Standards](#), p. 135).

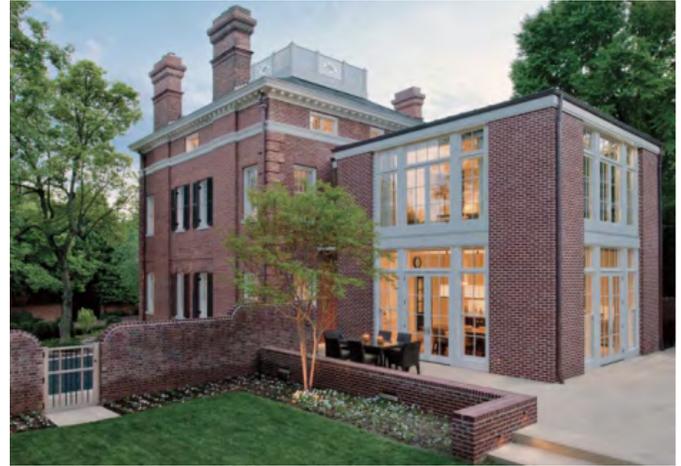
**DO.** Based on the materials, design, and placement at the rear of the house, this is a compatible new addition to the historic structure ([Secretary of the Interior’s Rehabilitation Standards](#), p. 157).

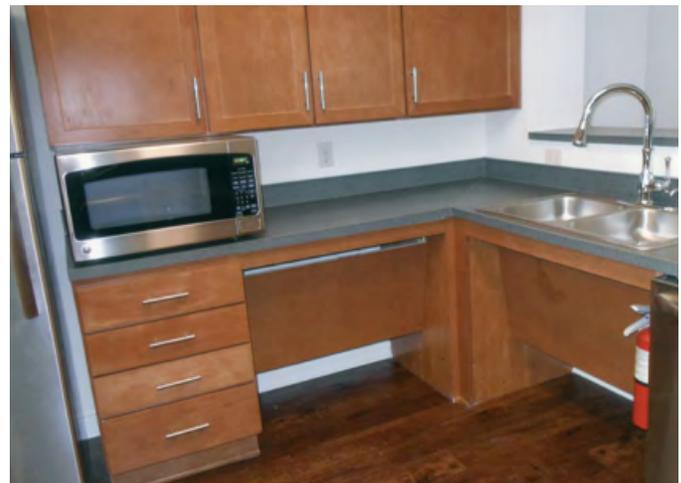
**DO.** This kitchen in an historic building was rehabilitated to meet accessibility requirements ([Secretary of the Interior’s Rehabilitation Standards](#), p. 147).

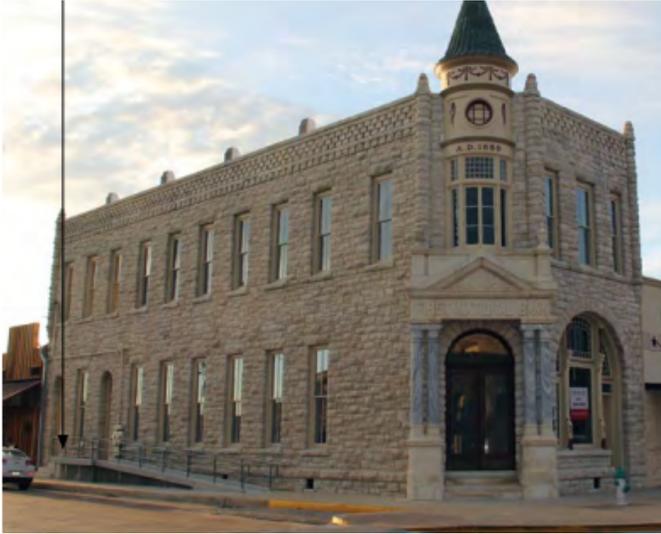
**DO.** This access ramp is on the side and blends into the stone façade so as not to impact the historic character of the building ([Secretary of the Interior's Rehabilitation Standards](#), p. 148).

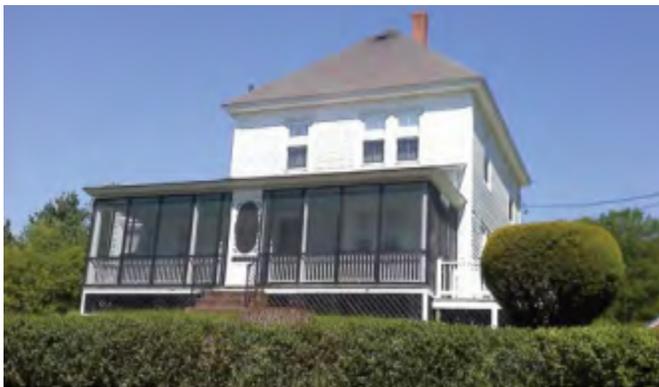
**DON'T.** Installing a screened enclosure is never recommended on a front entrance area ([Secretary of the Interior's Rehabilitation Standards](#), p. 112).

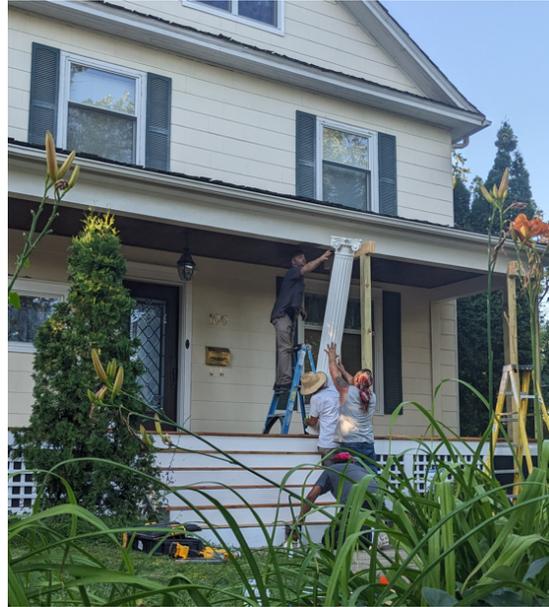
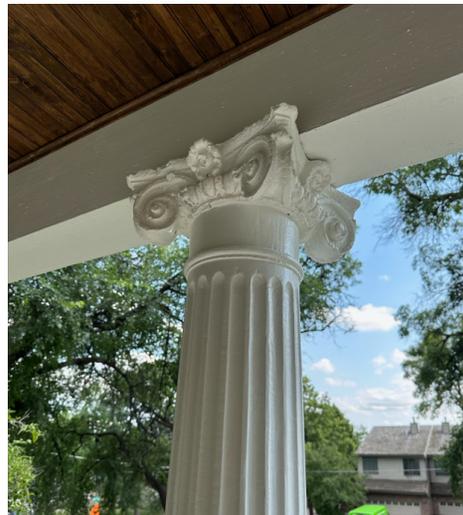
**DO.** The owner of this house in Bismarck's Cathedral District restored the original columns and capitals on the porch which included scraping, painting, and straightening them using the original materials.

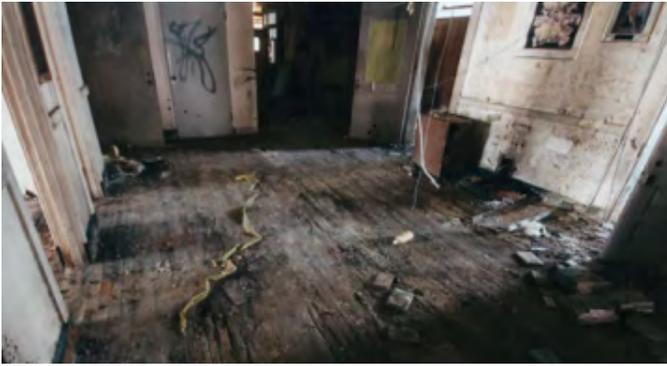
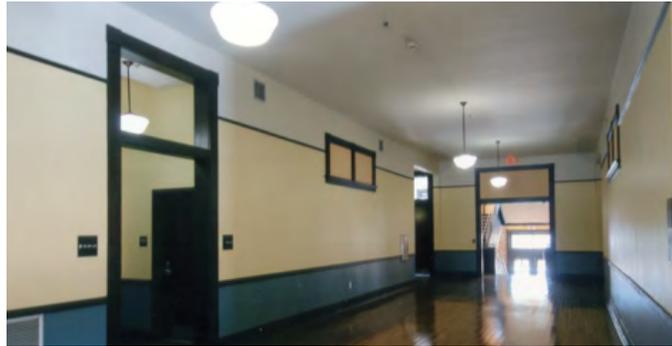
**DO.** The character-defining features, including the doors, were retained and repaired in this previously deteriorated historic school corridor ([Secretary of the Interior's Rehabilitation Standards](#), p. 129).

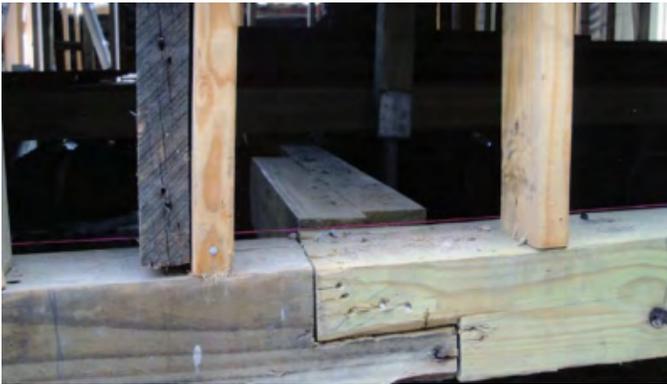
**DO.** This project replaced only the termite-damaged wood in order to retain as much of the historic wood sill plate ([Secretary of the Interior's Rehabilitation Standards](#), p. 121).
